PEDERNALES PEAK INSPECTIONS

TEXAS TREC REI 7-6 PROPERTY INSPECTION

# 7214 Manchaca Vista Dr Austin, TX 78745

## Austin Property Inspection Report

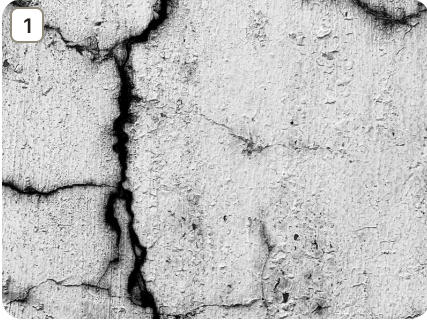
**Diagonal slab crack, engineer review****MAJOR DEFICIENCY**

A hairline-to-1/8 inch diagonal crack was observed in the slab at the ground-floor living room, with some minor cosmetic drywall cracking near nearby interior door frames consistent with foundation movement. Recommend evaluation by a licensed structural engineer prior to closing to determine whether monitoring or foundation repair is warranted.

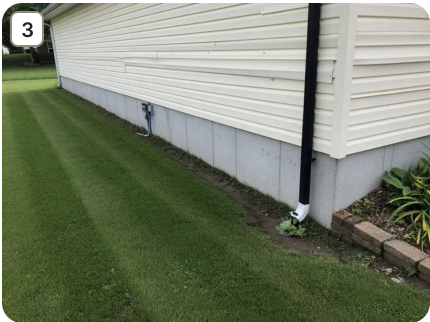
MINOR DEFICIENCY

Grade along the rear elevation, near the area of slab movement noted in I.A, is flat to slightly negative rather than sloping away from the structure. Recommend re-grading and extending downspouts to direct water away from the foundation.

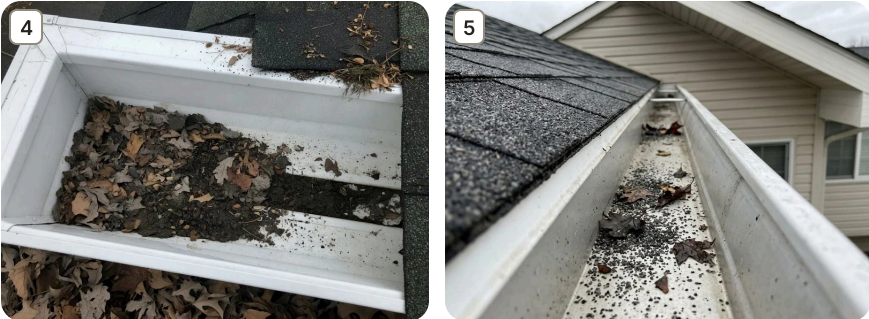
Leaves and shingle granules have built up in the rear gutters, and water was standing in the run above the patio. Clogged gutters overflow at the foundation, which adds to movement in clay soil. Clean the gutters and check that they slope toward the downspouts.

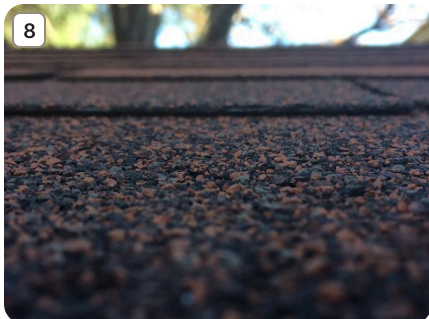
**Shingles at end of service life****MAJOR DEFICIENCY**

Composition shingles show significant granule loss, curling, and several cracked tabs consistent with a roof at or near the end of its serviceable life (the home's original 1990s roof, per the seller's disclosure). No active leaks were observed at the time of inspection, but recommend budgeting for roof replacement in the near term and monitoring the attic decking for water staining in the meantime.

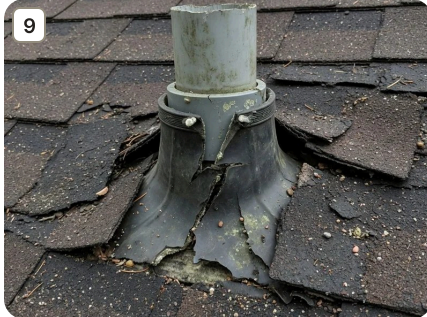
**Cracked plumbing vent boot****MAJOR DEFICIENCY**

The rubber boot around a plumbing vent on the rear slope is cracked and split open. Water can run down the pipe into the attic, and staining was found below it (see I.D). Recommend a qualified roofing contractor replace the boot now, even if the roof will be replaced later.

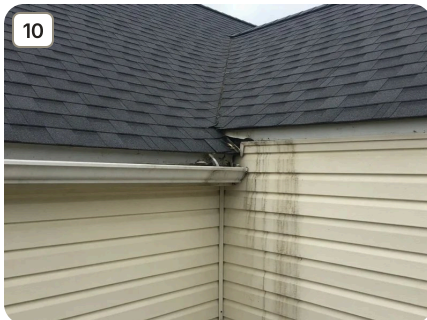
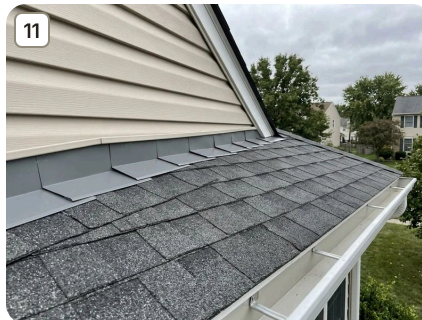
**Missing kick-out flashing****MAJOR DEFICIENCY**

There is no kick-out flashing where the garage roof edge meets the second-story side wall, and the siding below shows water staining. Without it, roof water runs behind the siding and into the wall. Recommend a qualified roofing contractor add kick-out flashing and check the wall behind for damage.

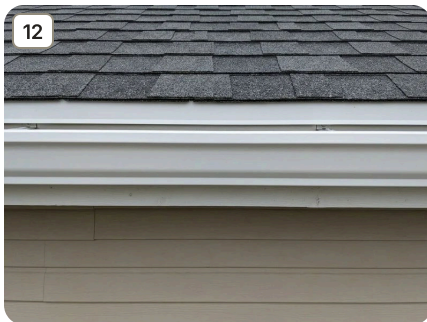
**Lifted and creased shingles****MINOR DEFICIENCY**

Several tabs along the west eave are lifted and creased from wind, and one tab is missing near the rake edge. Loose tabs let wind-driven rain under the roof. Recommend repair by a qualified roofing contractor, or include it in the roof replacement.

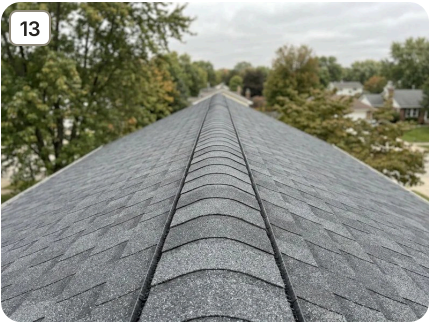
Nail heads are exposed and unsealed on several ridge cap shingles, and a few are backing out. Seal the nail heads or reset the caps to keep water out.

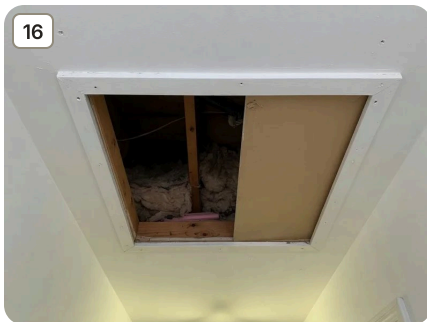
**Thin attic insulation and hatch****MINOR DEFICIENCY**

Attic insulation measured less than 3 inches in depth across most of the attic floor, well below the depth recommended for this climate zone, and the attic access hatch itself is uninsulated with no weatherstripping. Recommend adding blown insulation and an insulated, weatherstripped hatch cover to improve energy efficiency.

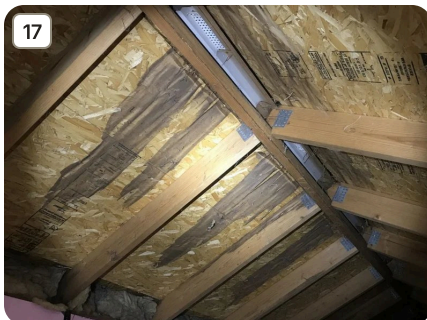
**Stained roof decking****MAJOR DEFICIENCY**

Dark water staining was found on the roof decking and one rafter below the cracked vent boot noted in I.C. The stain read dry today, but the leak path is still open. Staining like this may indicate moisture. Recommend repair by a qualified roofing contractor and evaluation by a licensed professional if further concern exists.

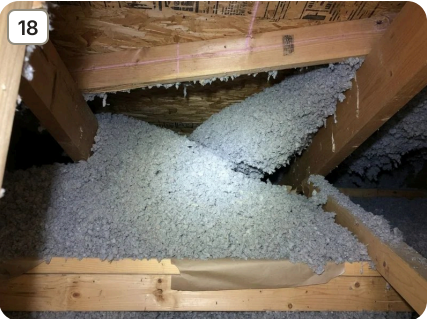
Soffit vents blocked

MINOR DEFICIENCY

Insulation is pushed tight against the soffit vents along the front eaves, so outside air cannot enter the attic there. Poor airflow traps heat and moisture and shortens shingle life. Install vent baffles when insulation is added. Recommend a qualified insulation contractor.

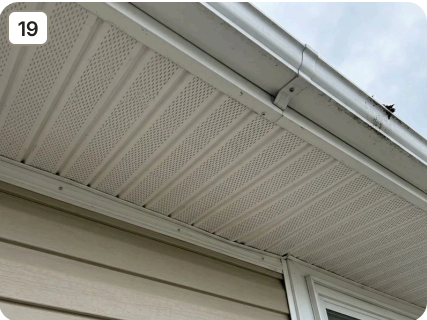
Deteriorated fascia and soffit

MAJOR DEFICIENCY

The fascia board is soft and the paint has failed at the rear eave above the deck, and a soffit panel next to it is loose. Water from the clogged gutter is soaking the wood. Recommend a qualified carpenter replace the damaged wood and paint it.

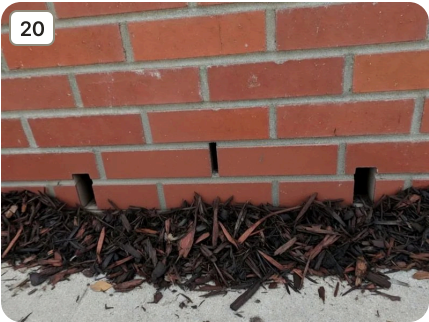
MINOR DEFICIENCY

Mulch covers the weep holes at the bottom of the brick veneer along the front bed. Weep holes let water that gets behind the brick drain out. Pull the mulch back and keep them open.

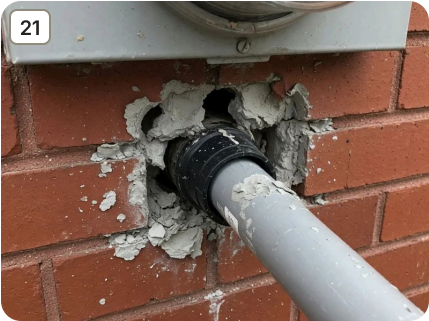
Gaps are open around the electrical service conduit, the hose bibs, exterior lights and the refrigerant lines where they pass through the walls. Seal them with an exterior sealant to keep water and pests out.

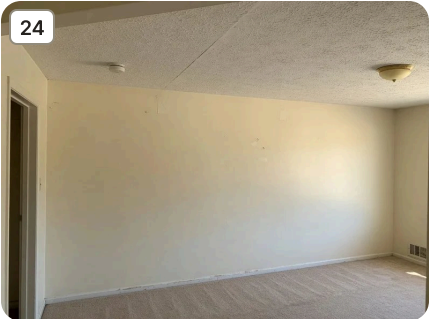
Ceiling joint crack upstairs

MINOR DEFICIENCY

A long crack runs along a drywall joint in the upstairs game room ceiling, and nail heads have pushed through the texture nearby. This is likely seasonal movement of the framing, but include it in the engineer's review and repair it after any foundation work.

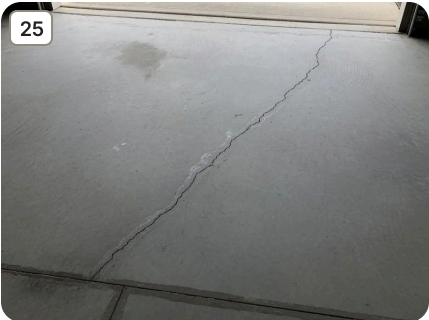
Garage floor cracks

Hairline shrinkage cracks run across the garage floor. These are common in concrete and are not a structural concern at this width. Monitor them and seal them if they widen.

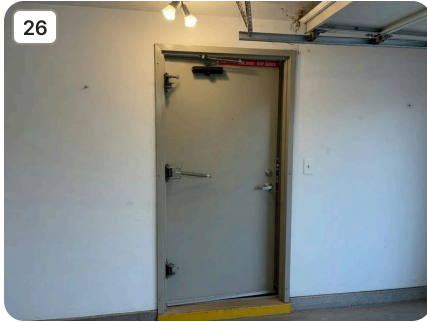
The steel door between the garage and the house has a closer and spring hinges, but when released it stopped short and did not latch, and there is a gap under the door. This door is meant to close on its own every time to slow fire and car exhaust from reaching the living space. Adjust the closer and add a bottom seal. Recommend a qualified door contractor.

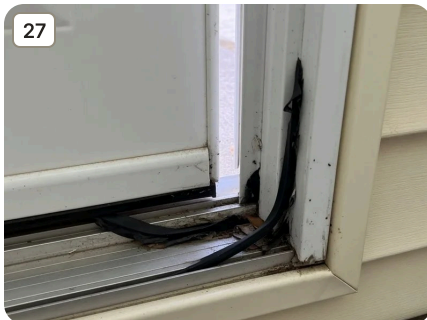
**Worn patio door weatherstrip****MAINTENANCE ITEM**

The weatherstrip on the rear patio door is torn and flattened, and daylight shows at the latch side. Replace it to stop air and water leaks.

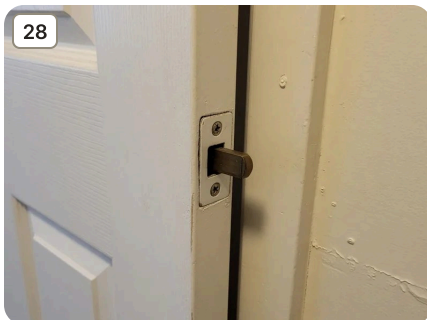
**Bedroom door does not latch****MINOR DEFICIENCY**

The upstairs front bedroom door latch does not line up with the strike plate, so the door will not stay shut. Adjust the strike plate. Doors going out of line can also follow slab movement (see I.A).

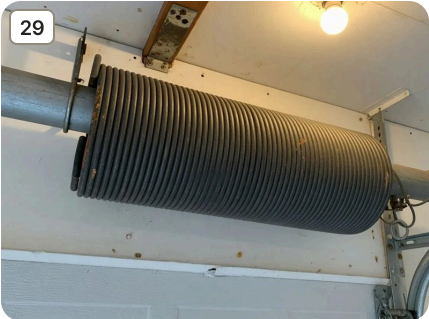
The torsion springs and rollers on both overhead garage doors are dry, and the doors are stiff to lift by hand. Have a qualified garage door technician lubricate, balance and adjust them. Do not adjust torsion springs yourself; they are under high tension.

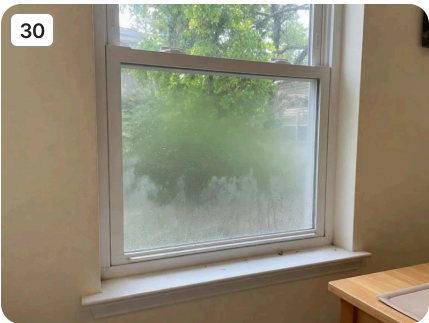
Several insulated windows (living room, and one upstairs bedroom) show fogging/condensation between panes, indicating failed seals on the insulated glass units. Cosmetic and an efficiency issue, not a safety concern. Recommend replacing the affected sash or glass units.

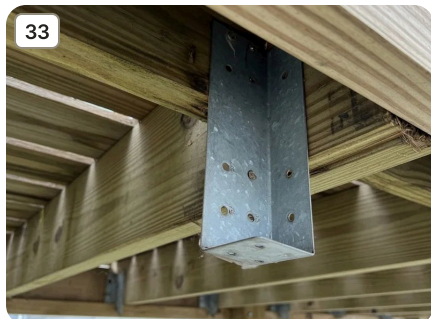
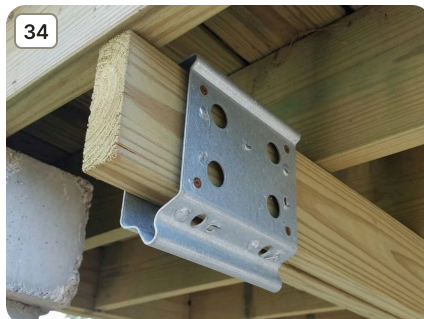
Several joist hangers at the deck ledger are missing nails, and one has only half of its holes filled. A hanger needs every nail hole filled to carry its load. Recommend a qualified deck contractor fasten them with the nails the hanger maker lists and check the ledger bolts.

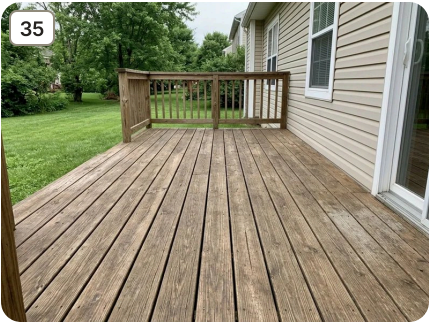
Deck boards are gray, cupped and split, with no sealer left on the surface, and a few boards near the house are soft. Replace the soft boards, then clean and seal the deck.

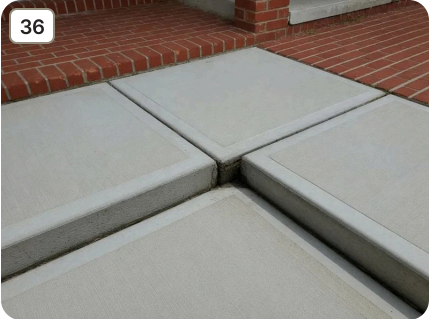
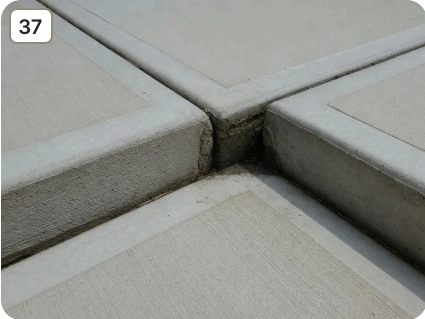
Trip hazard at front walk

One section of the front walk has settled about 1 inch below the next section, leaving a raised edge. This is a trip hazard. Grind or level the joint. Recommend a qualified concrete contractor.

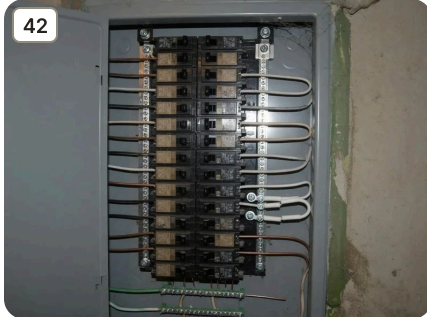
Double-tapped conductors were observed in the main panel (two conductors landed on a single terminal not rated for double connections), and the panel shows signs of age consistent with an original-to-the-home installation. Recommend evaluation and correction by a licensed electrician.

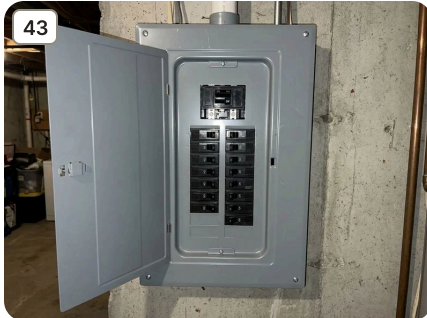
Many breakers are unlabeled or labeled in faded pencil. Each circuit should be clearly marked so power can be shut off fast in an emergency. Recommend a licensed electrician trace and label the circuits.

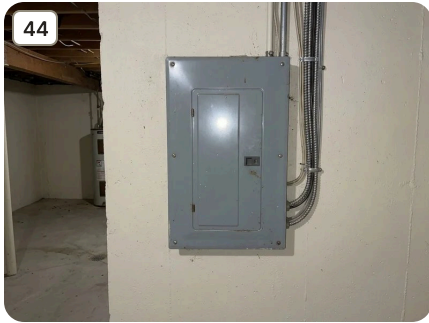
Two screws are missing from the panel's dead front cover, so it does not sit tight. Replace them with the blunt-tip screws made for the panel, not pointed screws that can pierce the wires behind.

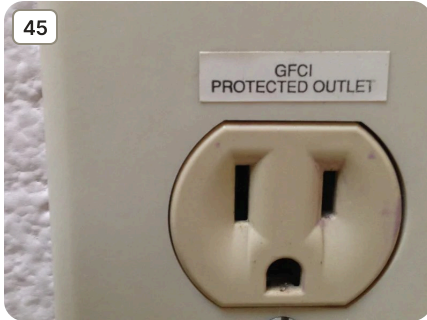
GFCI protection was not present at the kitchen counter receptacles. A "GFCI Protected Outlet" label was found on the hall bathroom receptacle, but the upstream GFCI device it references could not be located or tested during the inspection. Recommend a licensed electrician add GFCI protection at the kitchen counter and verify/repair the labeled protection at the bathroom receptacle.

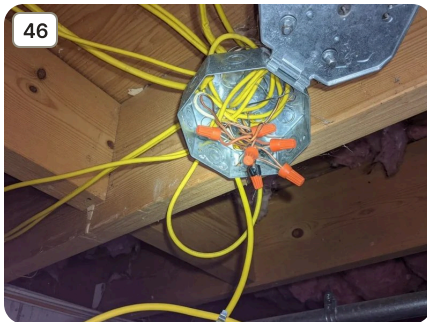
**Open junction box in attic****SAFETY HAZARD**

A junction box in the attic above the upstairs hall has no cover, leaving wire splices exposed where they can be touched or damaged. Install a cover. Recommend a licensed electrician.

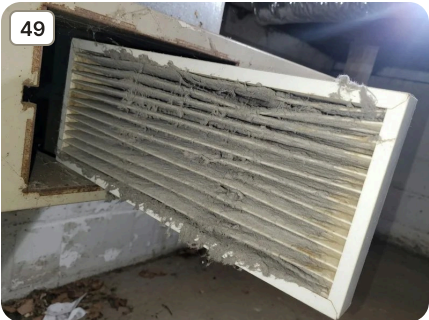
The return air filter is clogged with dust. A dirty filter cuts airflow, makes the system work harder and lets dust coat the coil. Replace the filter now and every 1 to 3 months.

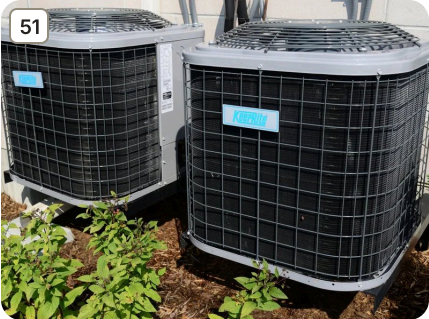
The condenser's exterior coil fins are heavily soiled and bent on the north face, restricting airflow and reducing cooling efficiency. Recommend a professional coil cleaning and fin comb service.

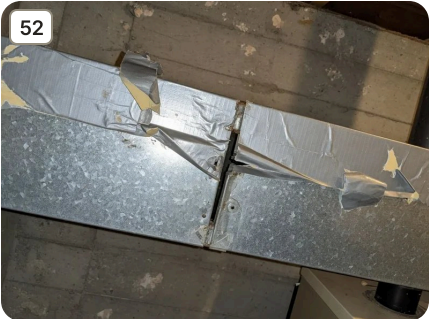
Tape at the supply plenum seams is peeling loose, and air could be felt leaking at the seams. Leaks send cooled air into the hot attic. Reseal the seams with mastic or listed foil tape. Recommend a licensed HVAC technician.
