**Pedernales Peak Inspections**

TEXAS TREC REI 7-6 PROPERTY INSPECTION

**1140 Ranch Road 12 Dripping Springs, TX 78620**

**Texas Property Inspection Report**

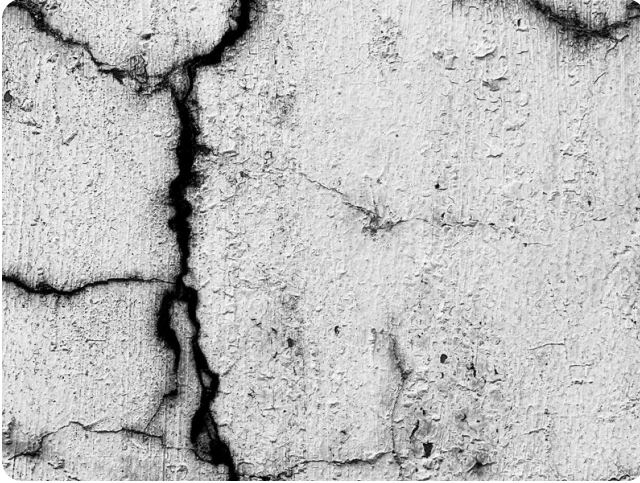
1

**Hairline crack in perimeter beam****MAJOR DEFICIENCY**

A hairline vertical crack, about 1/16 inch wide, was seen in the exposed perimeter beam below the kitchen window. There was no measurable offset and no related cracking in the limestone veneer above it or in the kitchen finishes. Cracks like this are common with slab movement in this clay soil. Recommend sealing the crack and monitoring it; if it widens or new cracks appear, have the foundation evaluated by a licensed professional engineer.

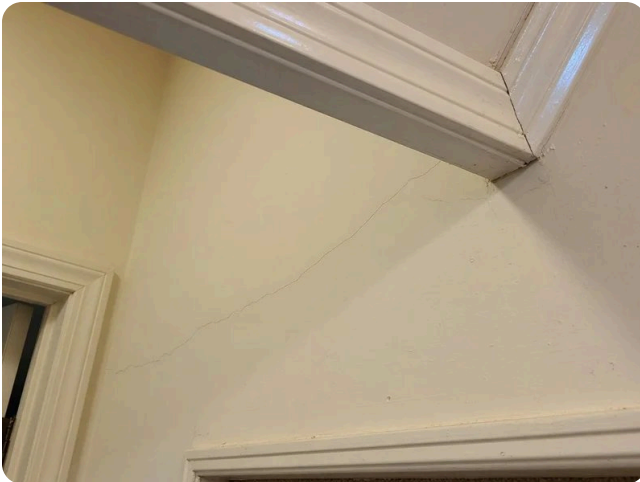
2

**Drywall crack at living room doorway****MINOR DEFICIENCY**

A hairline drywall crack runs up from the corner of the doorway between the living room and the hall. It shows no offset and is a common, minor sign of slab movement. Recommend patching and monitoring; report any widening to a licensed professional engineer.

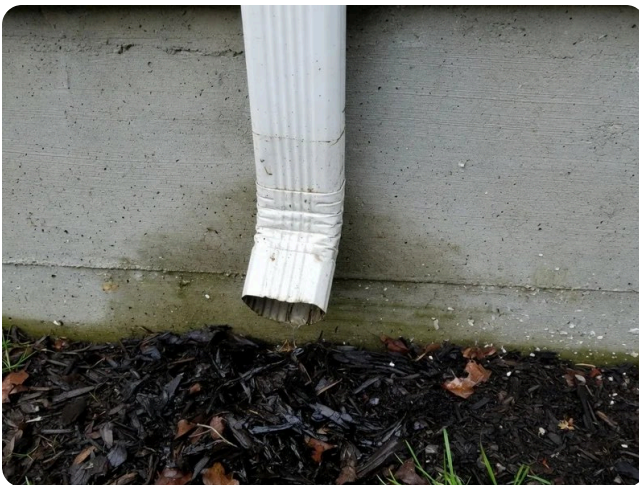
3

**Downspouts discharge at the slab****MINOR DEFICIENCY**

The downspouts at the rear left corner and at the garage wing end right at the slab with no extension or splash block. Roof water soaking the clay at the slab adds to seasonal movement. Recommend extensions that carry water at least 5 feet from the house.

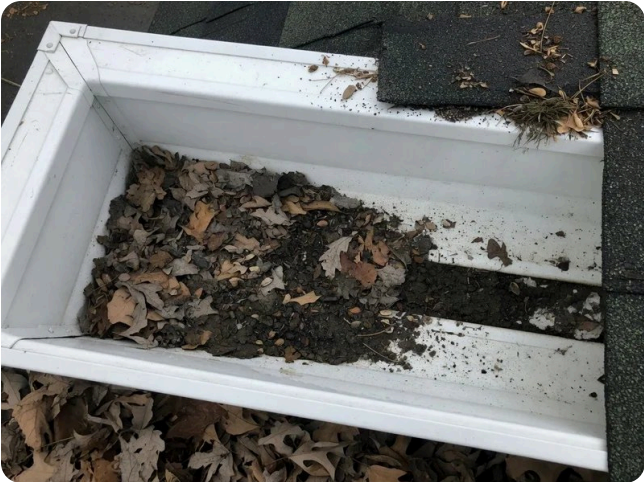
4

Gutters holding debris

Oak leaves and shingle granules fill the gutters at the rear addition and garage wing. Full gutters overflow at the foundation and can back water under the roof edge. Recommend cleaning the gutters and flushing the downspouts.

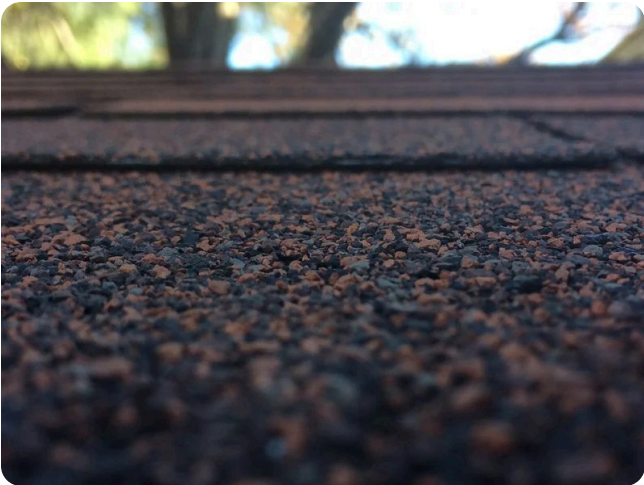
8

**Worn shingles at rear addition and garage**

**MAJOR DEFICIENCY**

The architectural composition shingles on the rear addition and the attached garage wing are estimated at 20 or more years old. Several tabs are cracked and granule loss is heavy on the south-facing slopes, consistent with the sun and hail exposure common in the Hill Country. These slopes are near the end of their service life. The metal roof over the main house is a separate covering and is covered in its own findings. Recommend evaluation by a qualified roofing contractor for repair or replacement of the shingle slopes.

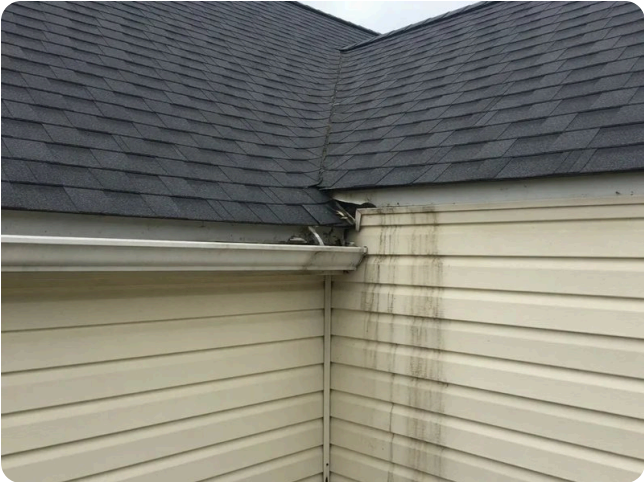
9

MAJOR DEFICIENCY

Where the porch roof and the garage wing roof meet the limestone walls, the flashing is face-sealed with caulk only. The caulk has cracked and pulled away from the uneven stone in several spots, and there is no cut-in counterflashing. Water can run behind the flashing into the wall. Recommend a qualified roofing contractor and a mason install proper counterflashing.

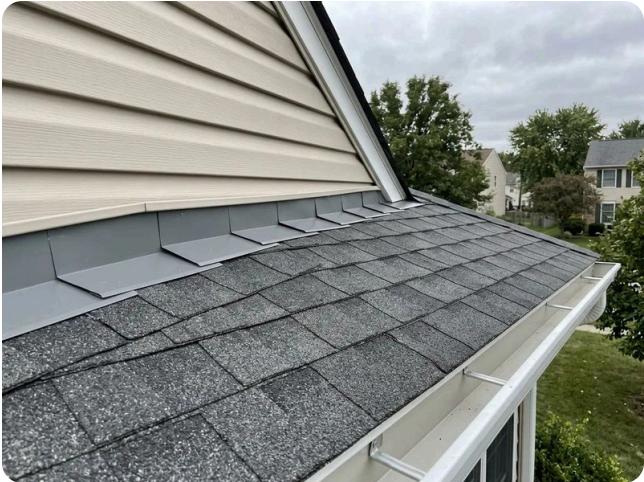
10

MAJOR DEFICIENCY

There is no kick-out flashing where the garage wing roof edge meets the siding on the side wall of the rear addition, and water staining runs down the siding below. Roof water is being sent down the wall at this spot. Recommend a qualified roofing contractor install kick-out flashing and check the wall sheathing behind the stain.

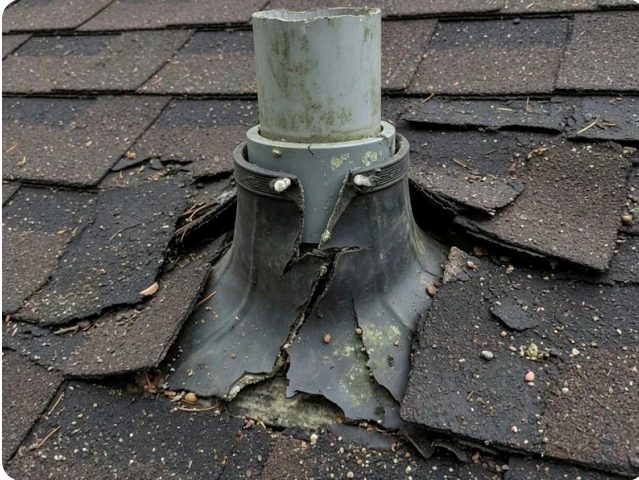
11

**Cracked plumbing vent boot****MAJOR DEFICIENCY**

The rubber boot around a plumbing vent on the garage wing roof is cracked and split at the collar. Water can run down the pipe into the attic, and stains were found on the decking below it. Recommend replacement by a qualified roofing contractor.

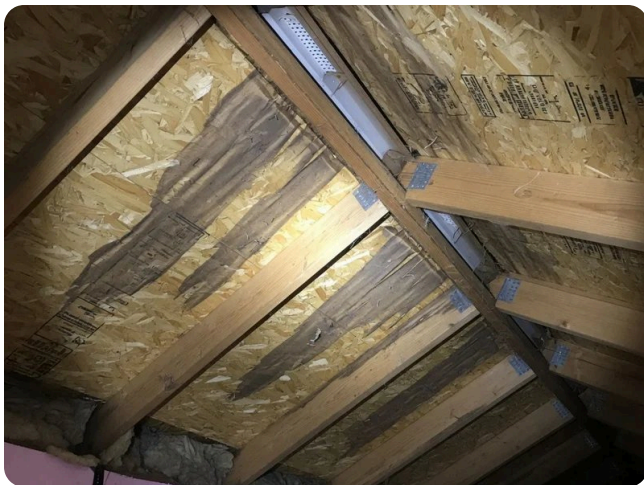
15

**Stained roof decking at garage wing****MAJOR DEFICIENCY**

Water stains were seen on the roof decking of the garage wing around the plumbing vent. The stains were dry at the time of the inspection but show past leaking, likely from the cracked vent boot listed under Roof Covering. Recommend a qualified roofing contractor repair the leak and check the decking for soft or damaged wood.

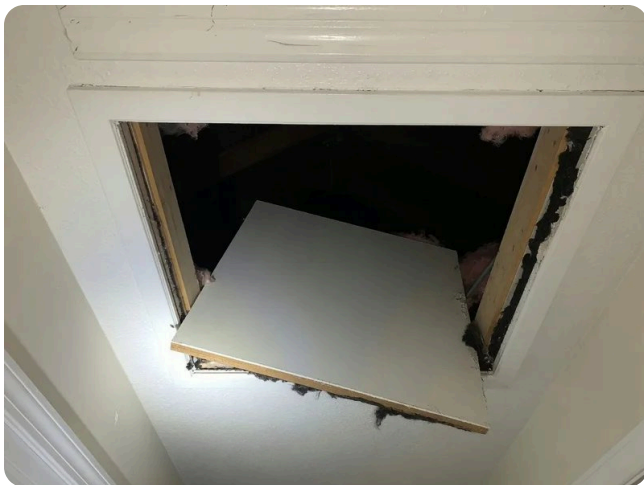
16

**Uninsulated attic hatch****MAINTENANCE ITEM**

The scuttle hatch in the hall closet has no insulation on top and no weatherstrip. Hot attic air leaks into the home here. Recommend adding rigid insulation and weatherstripping to the hatch.

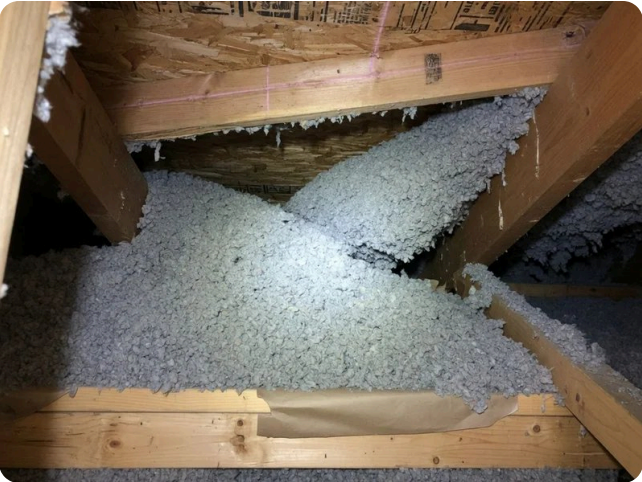
17

MINOR DEFICIENCY

Blown insulation is packed against the soffit vents along the rear eave of the main house, cutting off intake air. Poor airflow raises attic heat and can shorten roof life. Recommend installing vent baffles and pulling insulation back from the eaves.

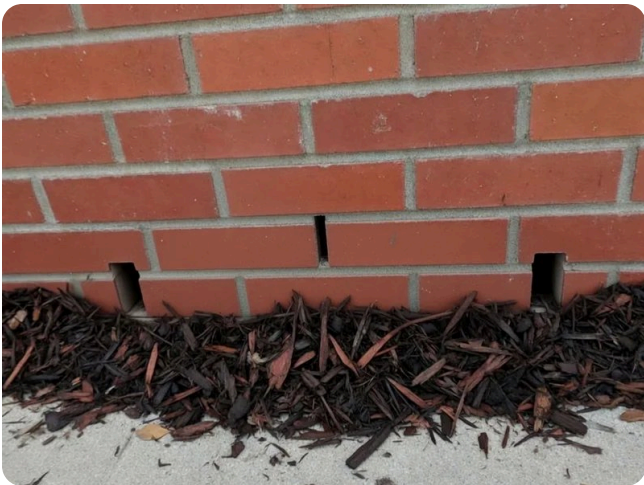
19

**MINOR DEFICIENCY**

Mulch along the garage wing covers the weep holes at the base of the brick. Weep holes let water drain out from behind the veneer. Recommend lowering the bed so the weeps stay open and at least 4 inches of slab shows.

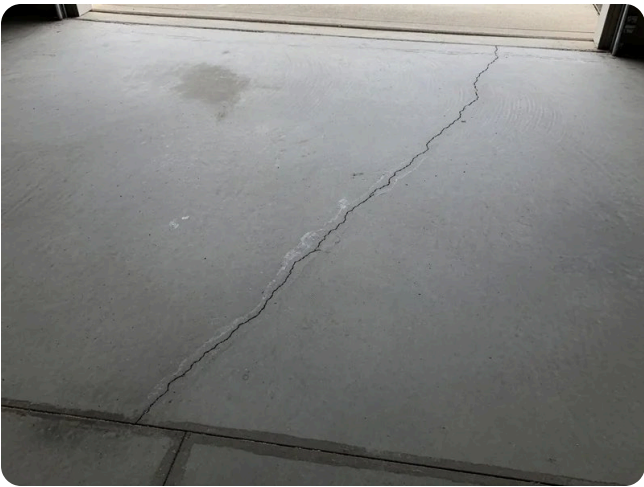
A hairline shrinkage crack runs across the garage floor with no offset. Cracks like this are common in garage slabs. Listed for monitoring.

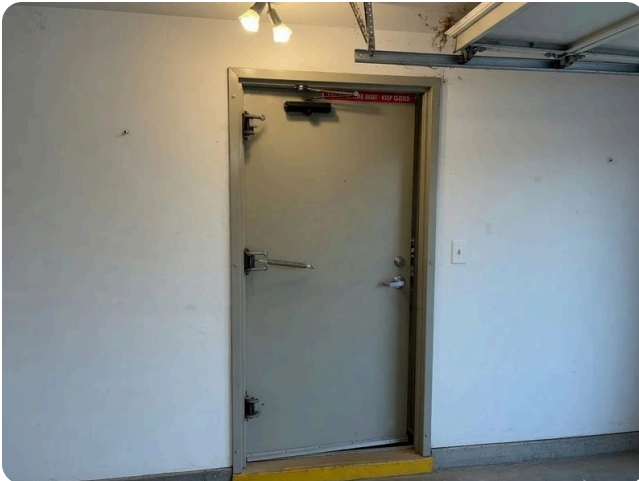
21

The door between the garage and the house does not close and latch on its own. This door should self-close to help keep fire and car exhaust out of the home. This is a safety item. Recommend a qualified contractor install self-closing hinges and confirm the door is solid-core or fire-rated.

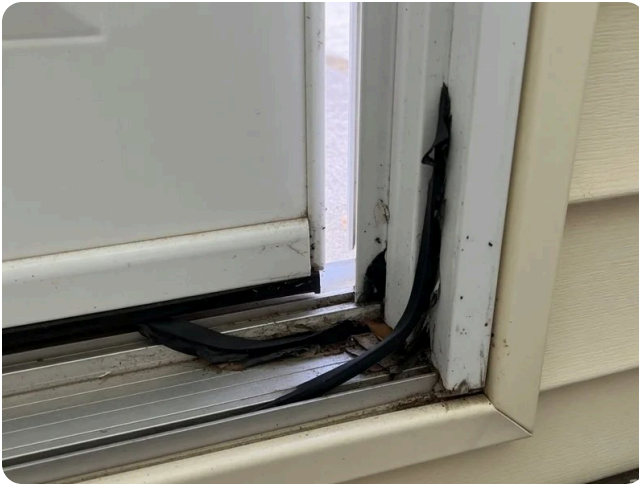
22

The weatherstrip on the sliding patio door to the deck is torn and flattened, and daylight shows along the edge. Air, dust and wind-driven rain can get past the door. Recommend replacing the weatherstrip.

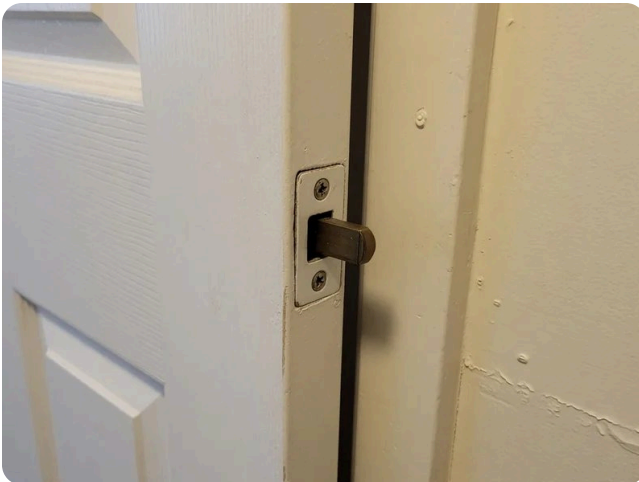
23

The second bedroom door does not latch because the latch meets the strike plate low. Recommend adjusting the strike plate or hinges.

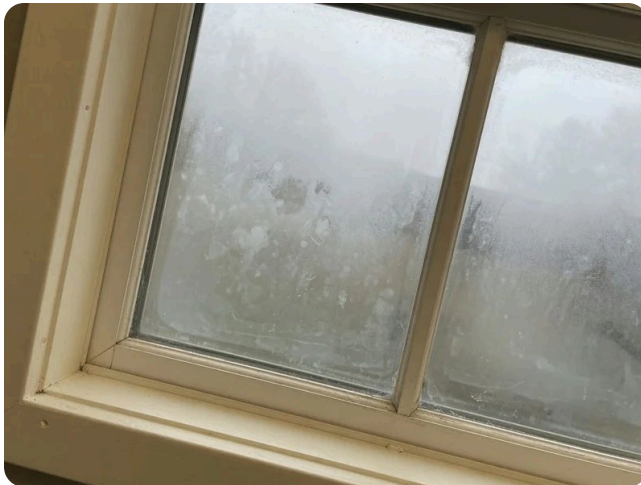
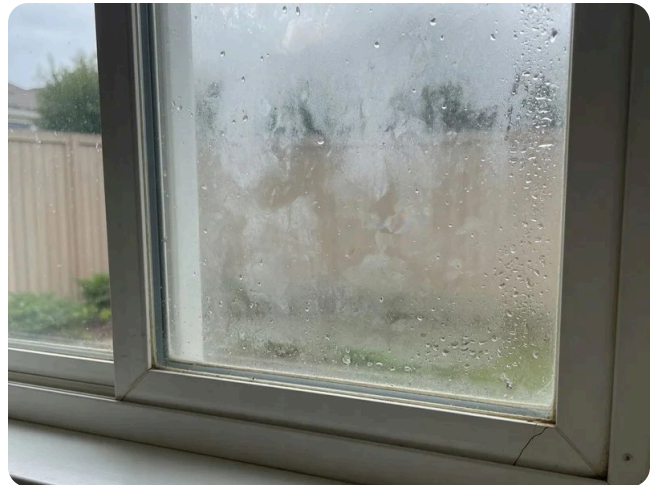
Fogging between the panes was seen at a second bedroom window and at the breakfast nook window, which means the seals have failed. Failed units lose insulating value and cloud the view. Recommend a qualified window contractor check all units and replace the failed glass.

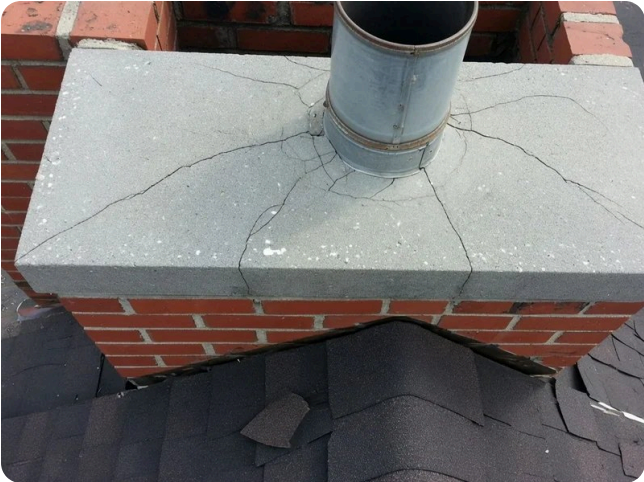
27

The mortar crown on top of the limestone chimney is cracked through in several places and pulling away from the flue. Water entering the cracks can damage the stone and the flue. Recommend repair by a qualified chimney sweep or mason.

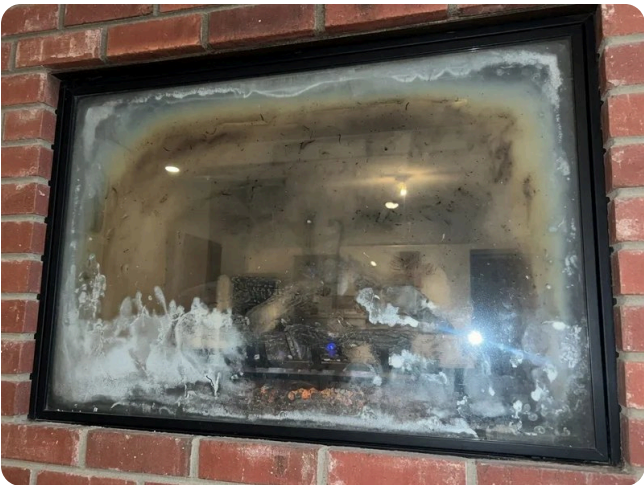
28

White residue coats the inside of the glass doors. Heavy buildup can point to poor burning or log placement. Recommend cleaning and having the gas logs serviced by a qualified gas fireplace technician.

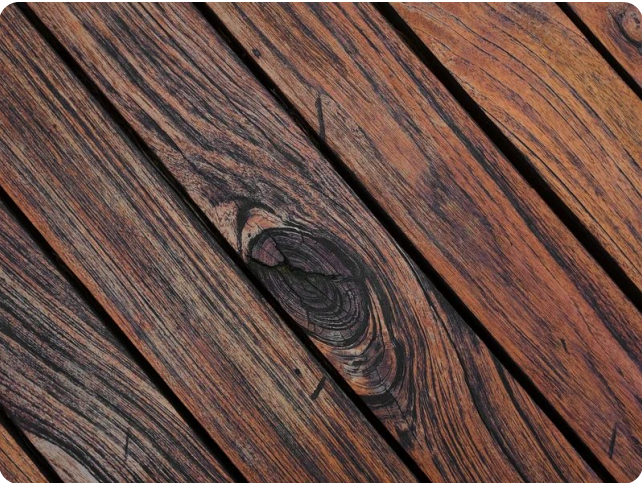
30

The rear covered deck has several boards with soft spots and early wood rot near the ground-contact support posts. Recommend evaluation and repair by a qualified deck contractor.

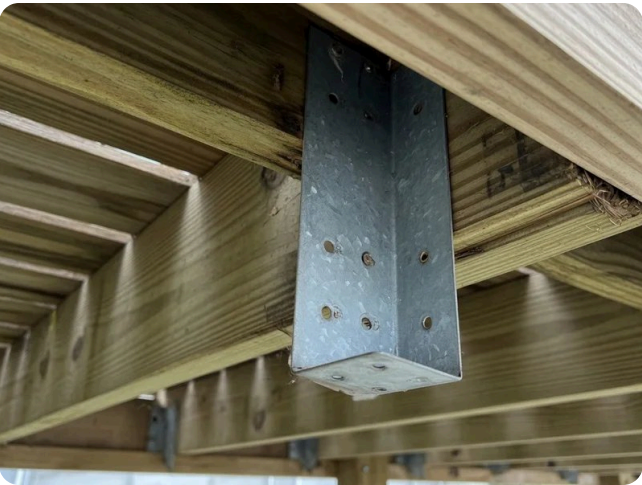
31

Several joist hangers at the deck beam have empty nail holes, and one is held by only two nails. Under-nailed hangers can let joists drop. Recommend a qualified deck contractor fill every hanger hole with the rated fasteners.

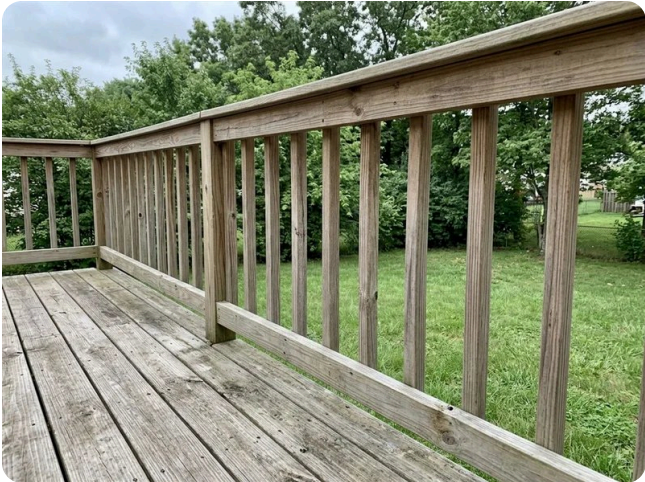
32

The guard rail on the open side of the deck moves when pushed, and one rail post is loose at the rim joist. A loose rail may not hold a person who leans or falls against it. This is a safety item. Recommend a qualified deck contractor secure the posts with through-bolts.

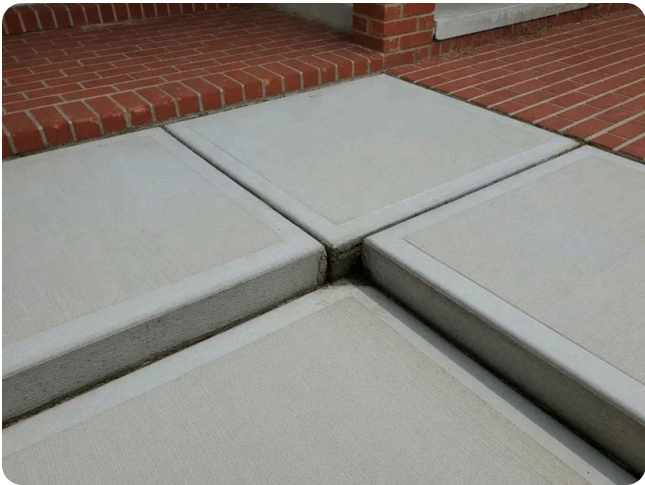
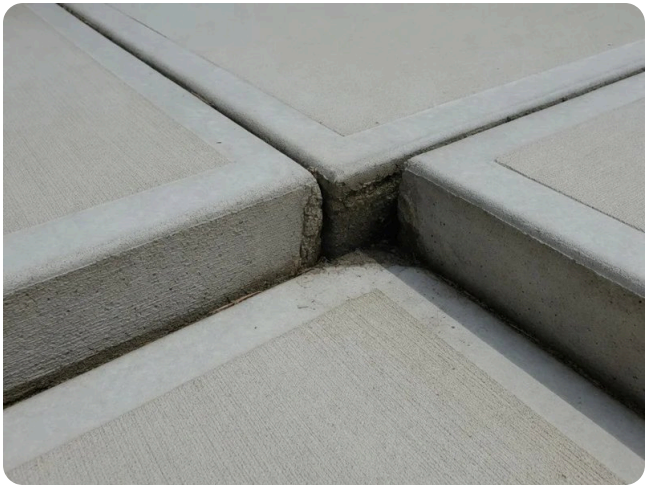
One section of the front walk has settled, leaving an edge about 1 inch high at the next slab. This is a trip hazard. Recommend grinding the edge or replacing the section.

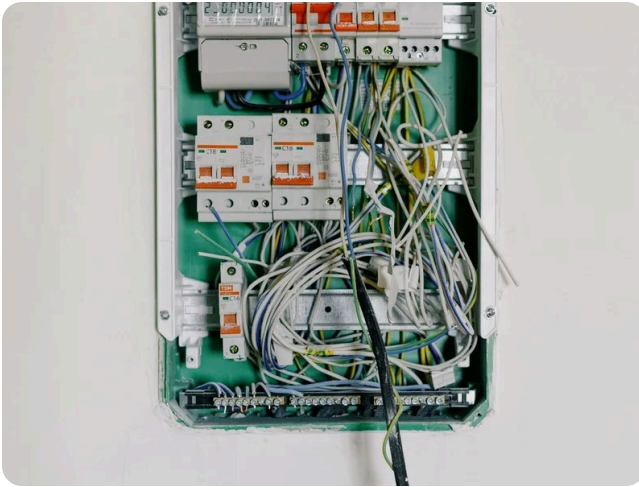
38

Two double-tapped breakers (rated for a single conductor) were found in the main electrical panel. Recommend evaluation and correction by a licensed electrician.

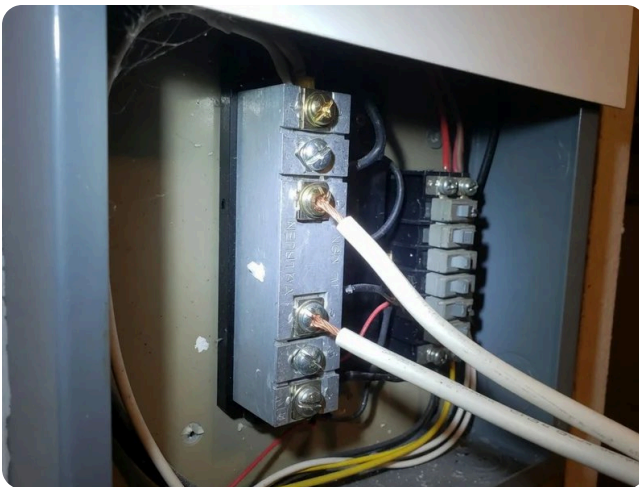
39

Two white neutral wires share one screw on the neutral bar in several places. Each neutral needs its own terminal so a loose wire does not overheat. Recommend correction by a licensed electrician.

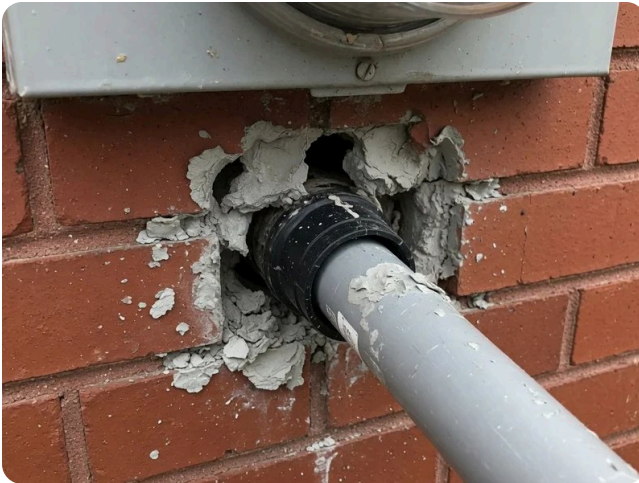
40

The gap where the service conduit enters the brick wall of the garage wing is not sealed. Gaps let water, insects and rodents into the wall. Recommend sealing with an exterior sealant.

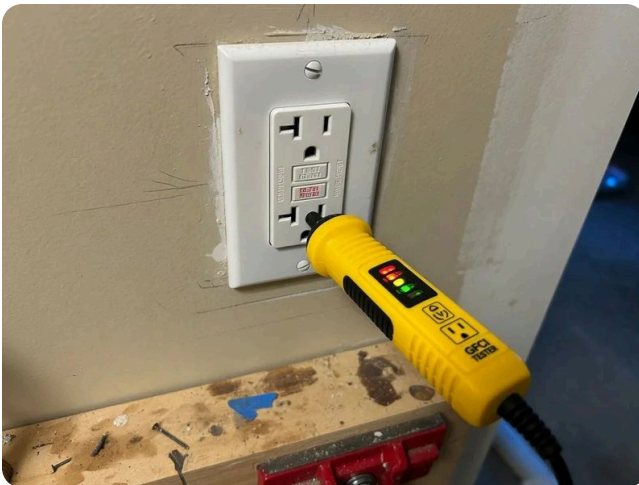
42

The GFCI outlet on the rear deck did not trip when tested, so it will not cut power in a ground fault. Outdoor outlets need working protection. This is a safety item. Recommend replacement by a licensed electrician.

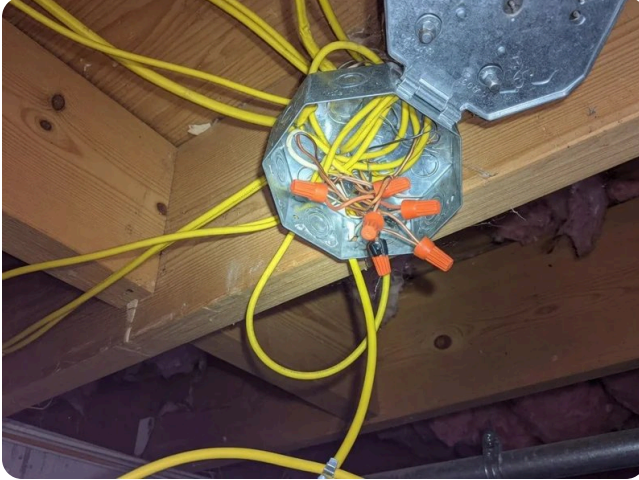
43

A junction box in the attic over the rear addition has no cover, leaving wire splices exposed next to the insulation. Open splices can shock or spark. This is a safety item. Recommend a licensed electrician install a cover.

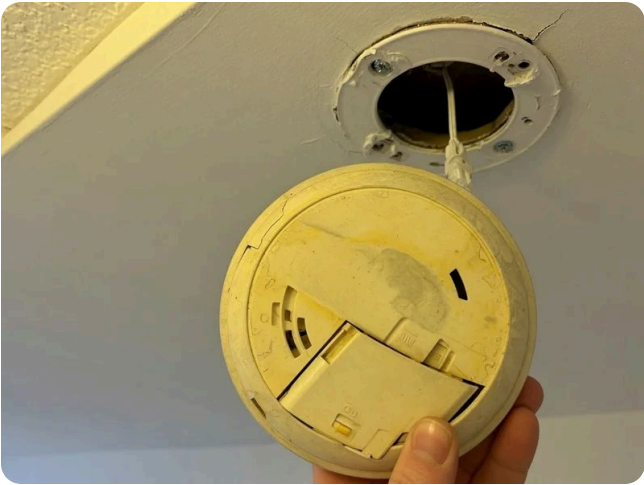
44

The hall and primary bedroom smoke alarms are yellowed, and their date labels show they are well past the 10-year replacement age. Old sensors lose sensitivity. Recommend replacing all the smoke alarms.

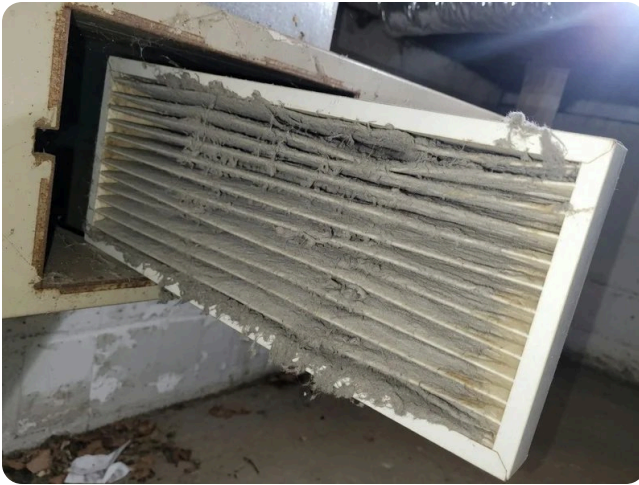
46

The return air filter at the hall ceiling grille is heavily loaded with dust. A dirty filter cuts airflow and makes the system work harder. Recommend replacing it now and every 1 to 3 months.

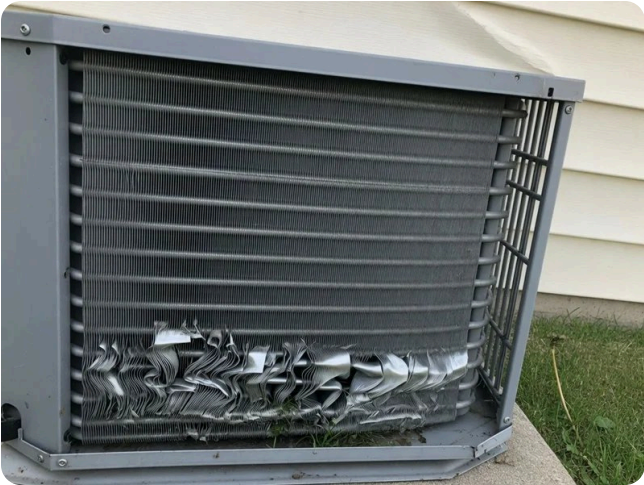
48

The condenser coil fins are bent flat in several areas and matted with dirt and grass clippings. Blocked fins cut cooling, raise power bills and wear the compressor. Recommend cleaning and combing the coil by a licensed HVAC technician.

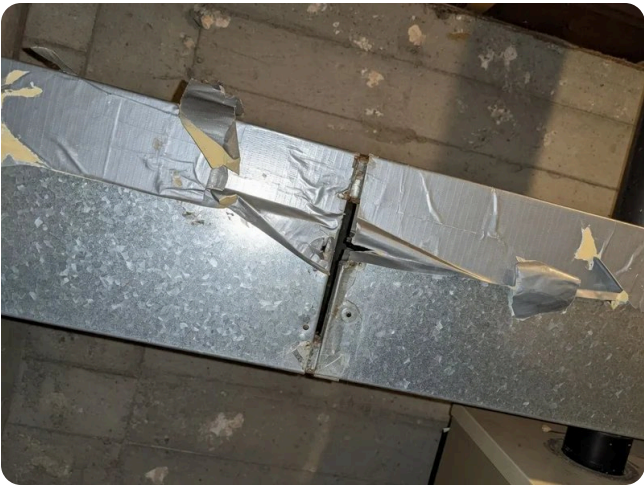
49

The tape sealing the supply plenum seams at the furnace has dried and peeled, leaving open joints that leak cooled air into the hot attic. Recommend a licensed HVAC technician reseal the joints with mastic.

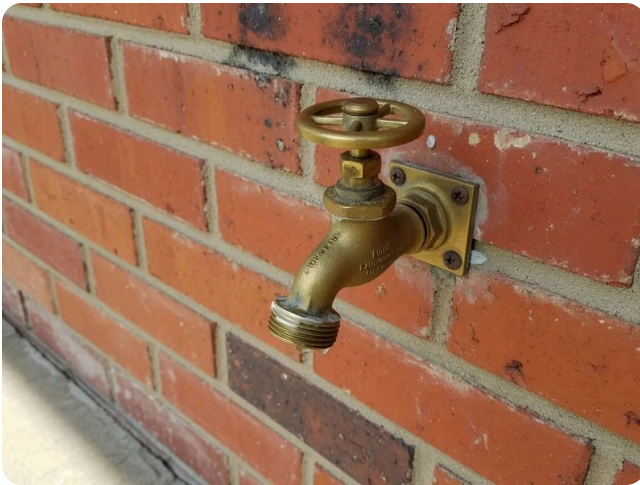
52

The hose bibs on the garage wing and in the rear yard have no vacuum breaker. Without one, dirty water from a hose can be pulled back into the house supply. Recommend screw-on vacuum breakers at each bib.

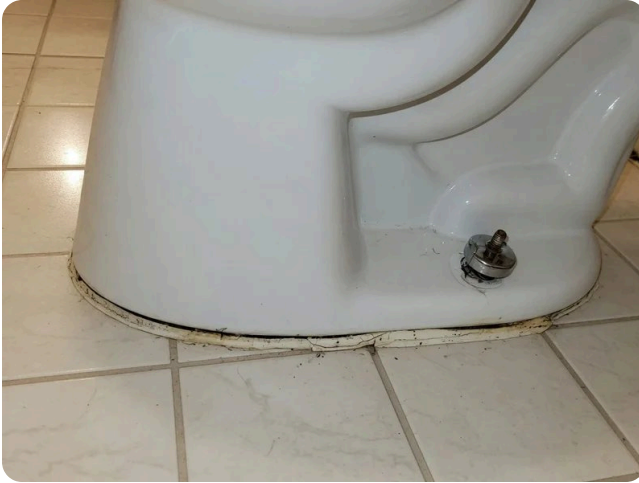
53

The hall bath toilet rocks on the floor and the caulk at its base is cracked. A loose toilet can break its wax seal and leak under the base. Recommend a licensed plumber reset it on a new seal.

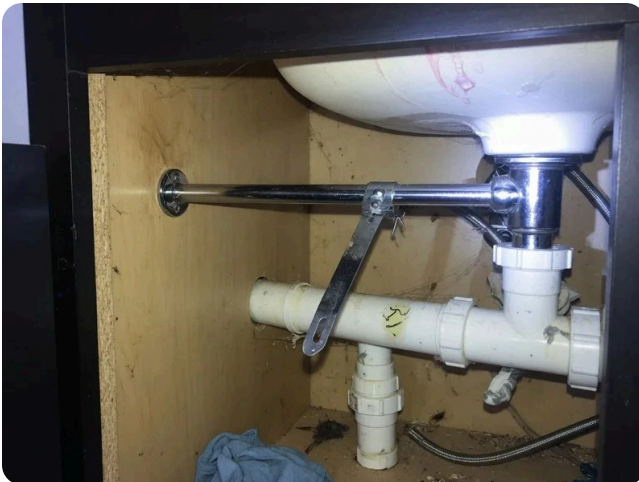
54

The hall bath sink stopper does not work because the pop-up rod is disconnected under the sink. Recommend reconnecting the rod.

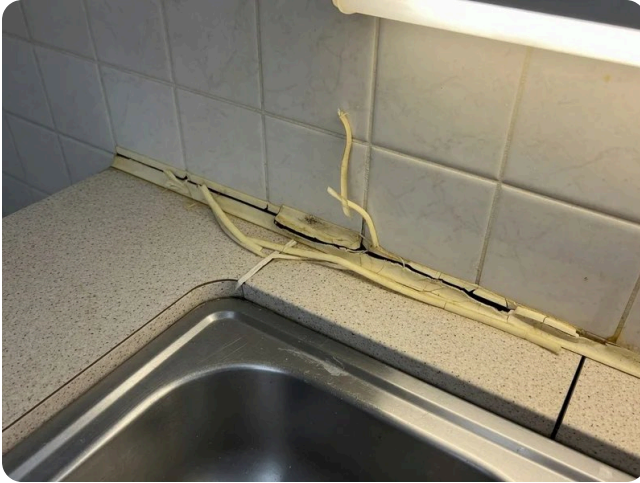
55

Caulk between the kitchen counter and the backsplash near the sink is cracked and open. Water can get behind the counter and into the sink cabinet. Recommend recaulking.

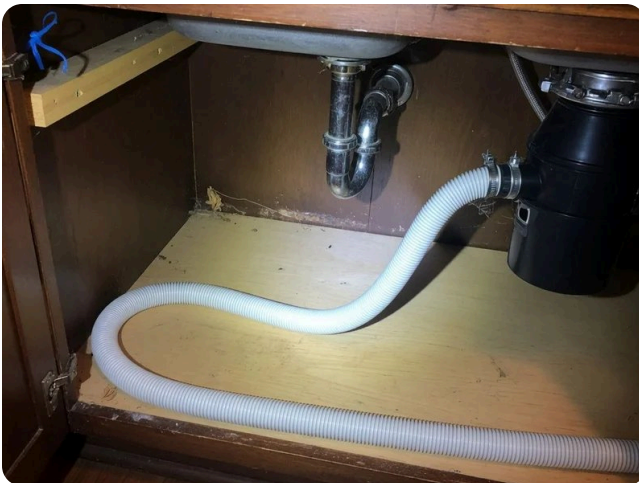
58

The dishwasher drain hose runs low under the sink with no high loop or air gap. Dirty sink water can flow back into the dishwasher. Recommend fastening the hose up high under the counter.

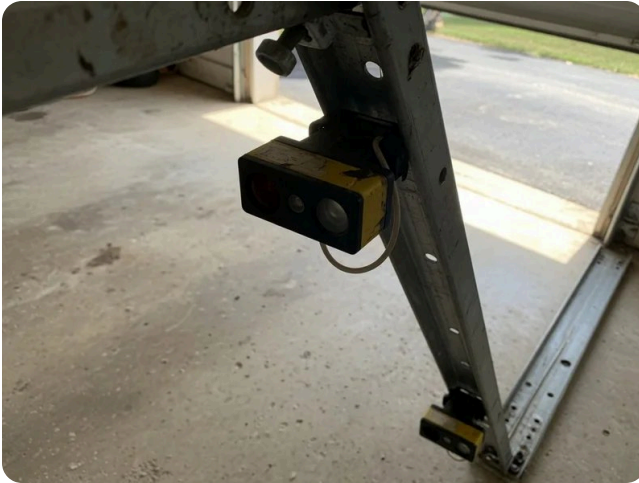
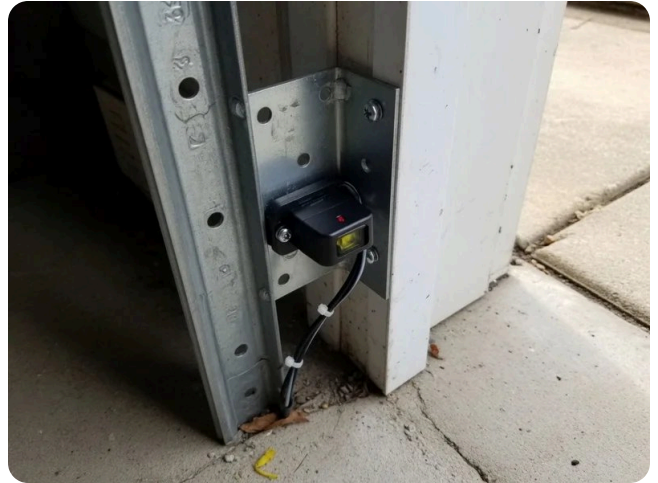
The safety sensors on the left overhead door are about 14 inches above the floor. They should be no more than 6 inches up so a small child or pet lying under the door is seen. This is a safety item. Recommend lowering the sensors.

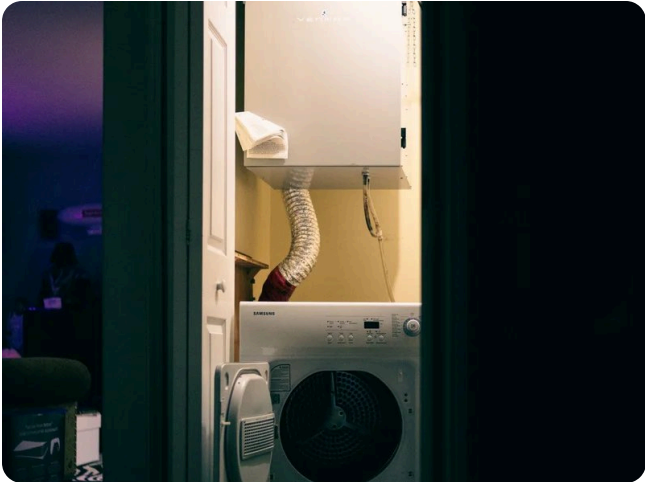
67

The dryer exhaust duct has heavy lint accumulation and the exterior vent flap is largely obstructed. This is a fire safety concern. Recommend having the duct professionally cleaned and the vent flap cleared immediately.

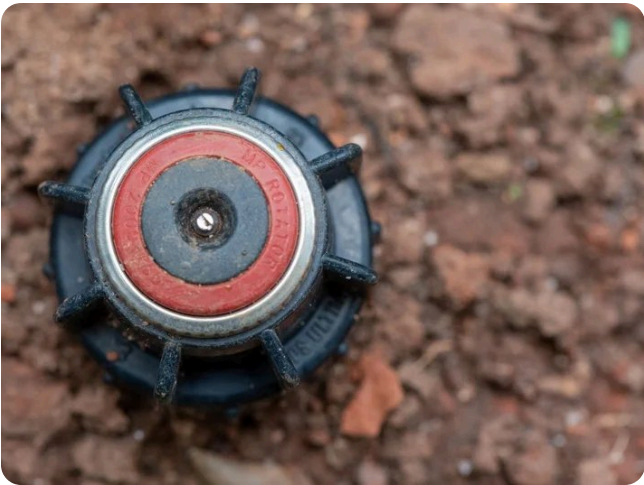
68

The sprinkler system was tested by zone. Zone 3 (rear planting beds) has a cracked spray head spraying directly onto the foundation rather than the landscaping. Recommend replacing the head and redirecting the spray pattern.

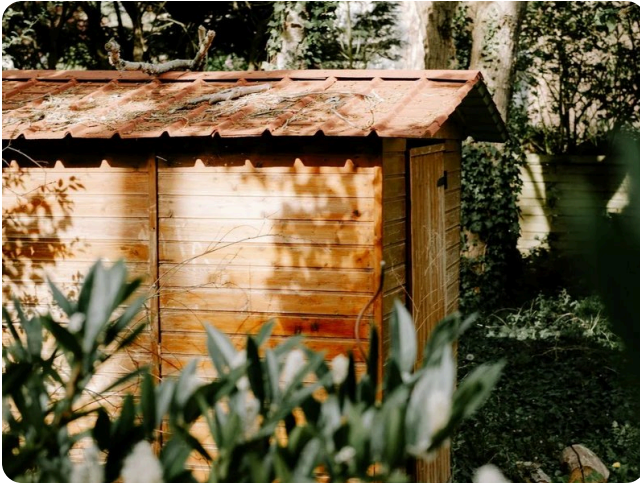
69

The detached wood-frame workshop shed is powered through an extension cord routed through a gap in the wall rather than a dedicated branch circuit. Recommend a licensed electrician install proper wiring and a dedicated circuit or subpanel to the structure.
