Pedernales Peak Inspections

Round Rock New Construction Inspection Report

September 28, 2026

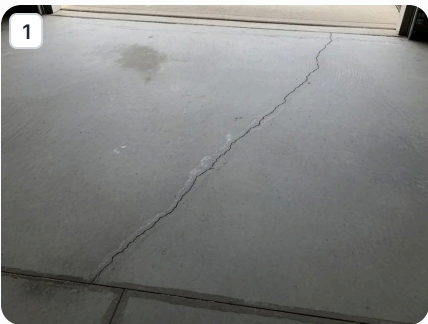
Hairline shrinkage crack in garage slab

A hairline crack runs across the garage floor slab. Cracks like this are common in new concrete as it cures and are not, by themselves, a sign of foundation movement. Monitor it, and have it sealed if it opens wider than about 1/16 inch.

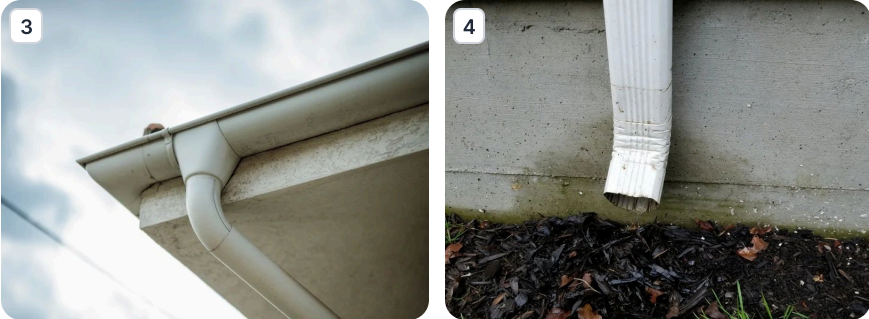
Downspouts discharge at the foundation

MINOR DEFICIENCY

Two downspouts at the rear elevation discharge directly at the foundation rather than being extended away from the structure with a splash block or extension. Recommend adding downspout extensions as part of the builder's standard punch-list scope.

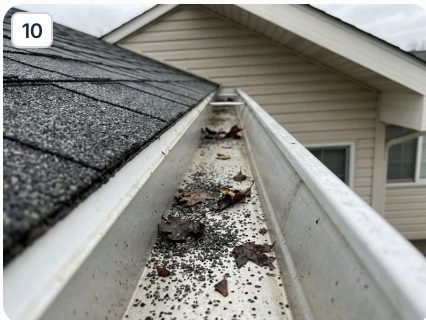
**Loose granules in the gutter**

A small amount of loose shingle granules and a few leaves were in the rear gutter. Some granule shedding is normal for new shingles during their first months and is not a defect.

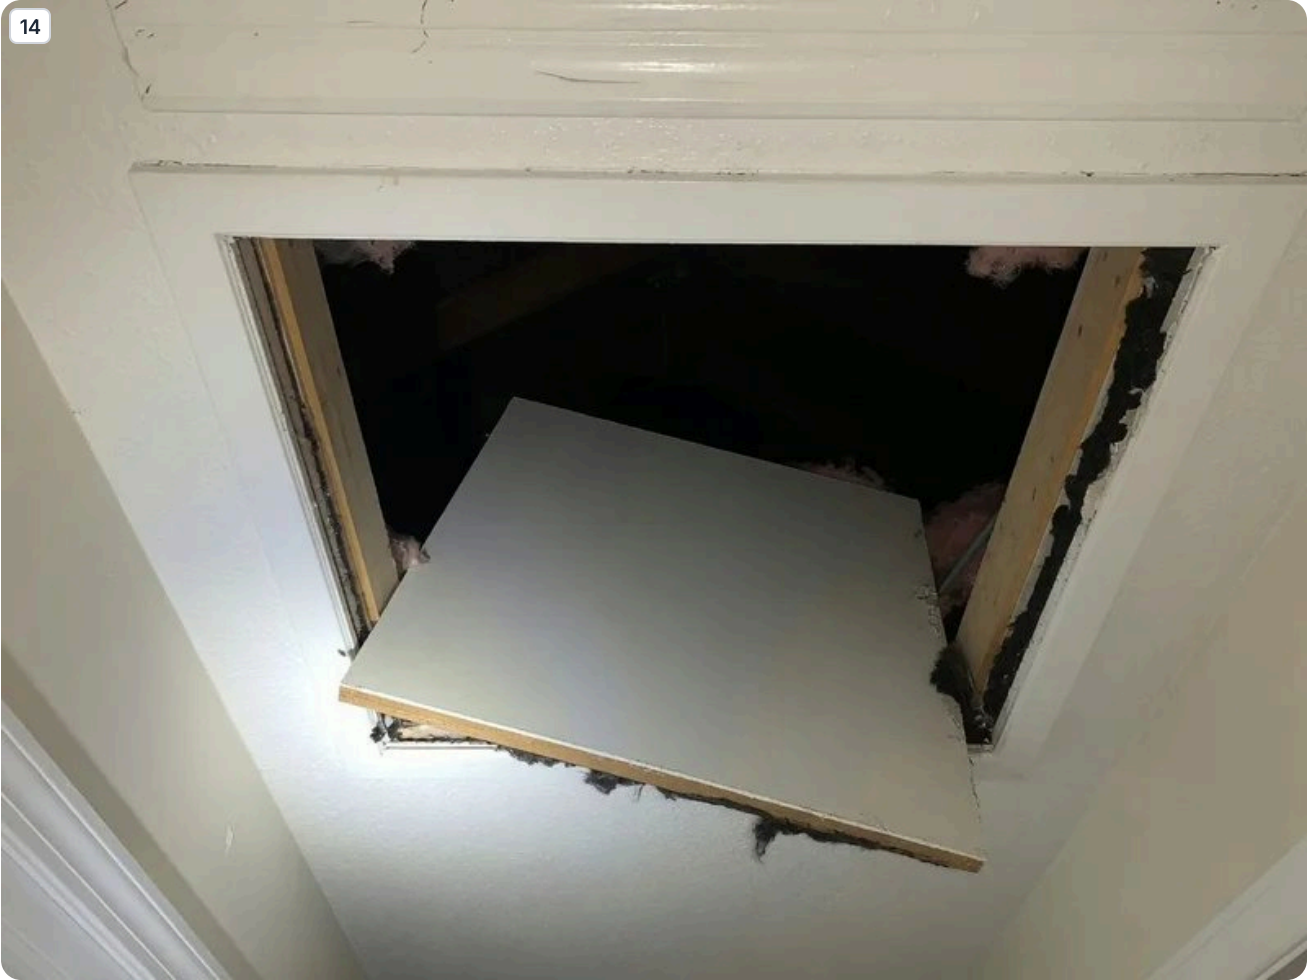
MINOR DEFICIENCY

The attic hatch in the hallway ceiling has no insulation on its top side and no weatherstrip around its edges. Hot attic air can leak into the house through it and raise cooling costs. Recommend the builder insulate and weatherstrip the hatch.

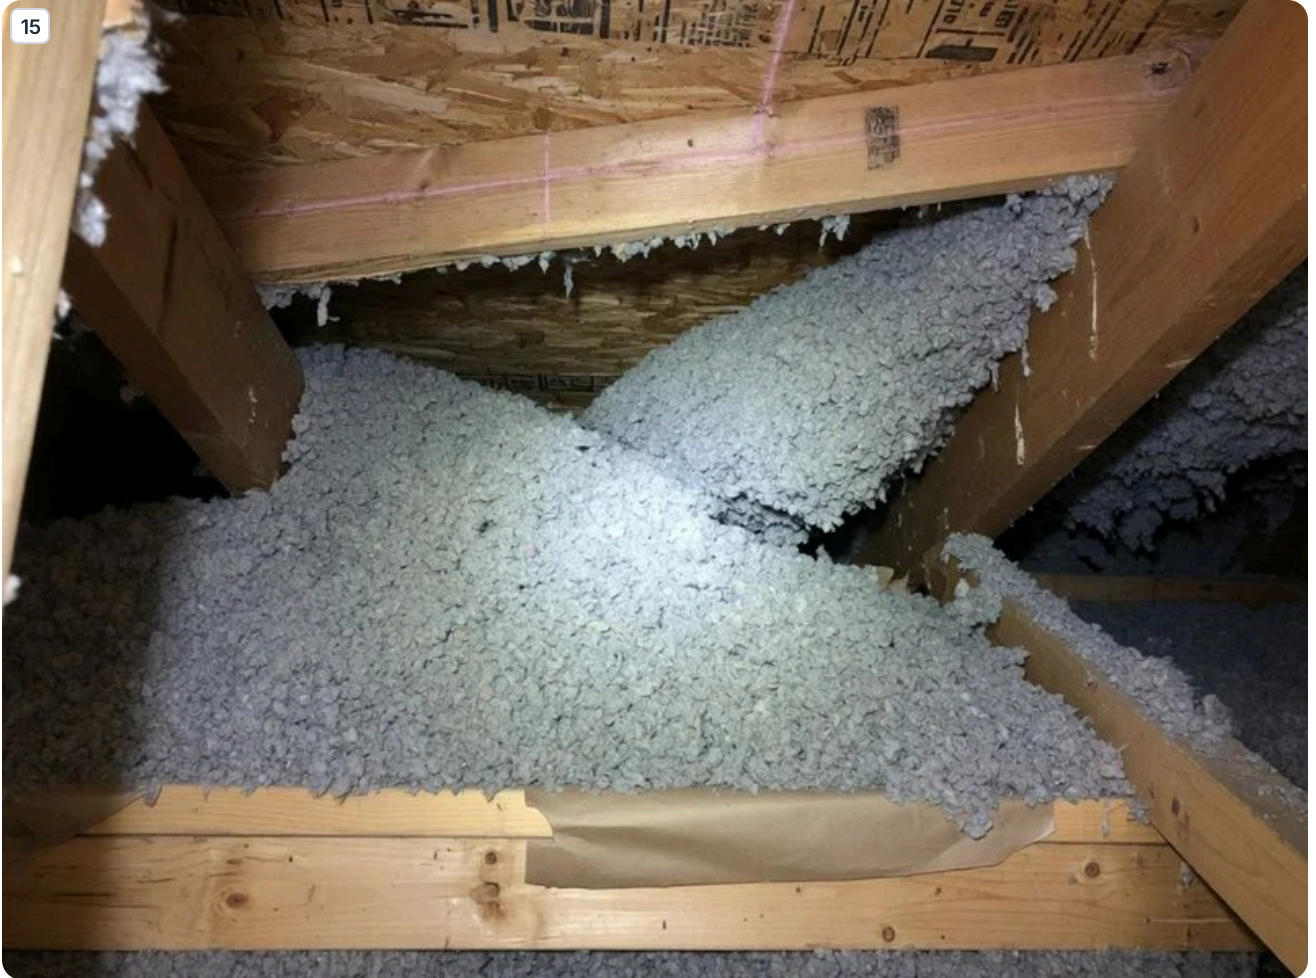
**MAJOR DEFICIENCY**

At the rear eaves over the primary bedroom, blown insulation is packed against the soffit vents and no baffles were seen in several bays. Blocked soffit vents cut the airflow through the attic, which traps heat and moisture under the roof. Recommend the builder install baffles and pull the insulation back from the vents.

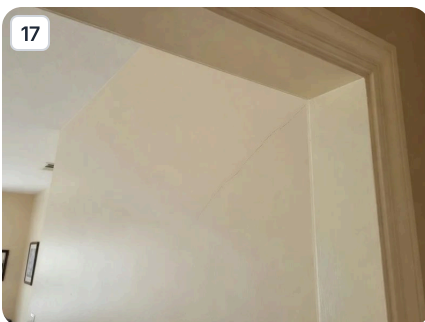
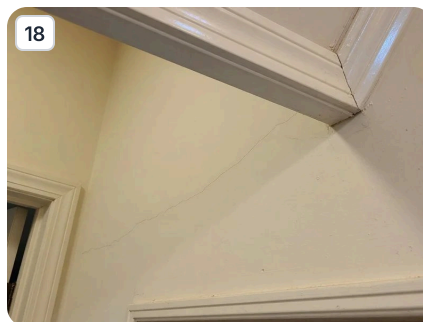
**Drywall nail pops and seam lines****MINOR DEFICIENCY**

Minor nail pops and a few short drywall seam lines are visible along the main hallway and above the living room doorway, typical of new-construction framing settling. Cosmetic; recommend touch-up paint as part of the builder's one-year warranty walkthrough.

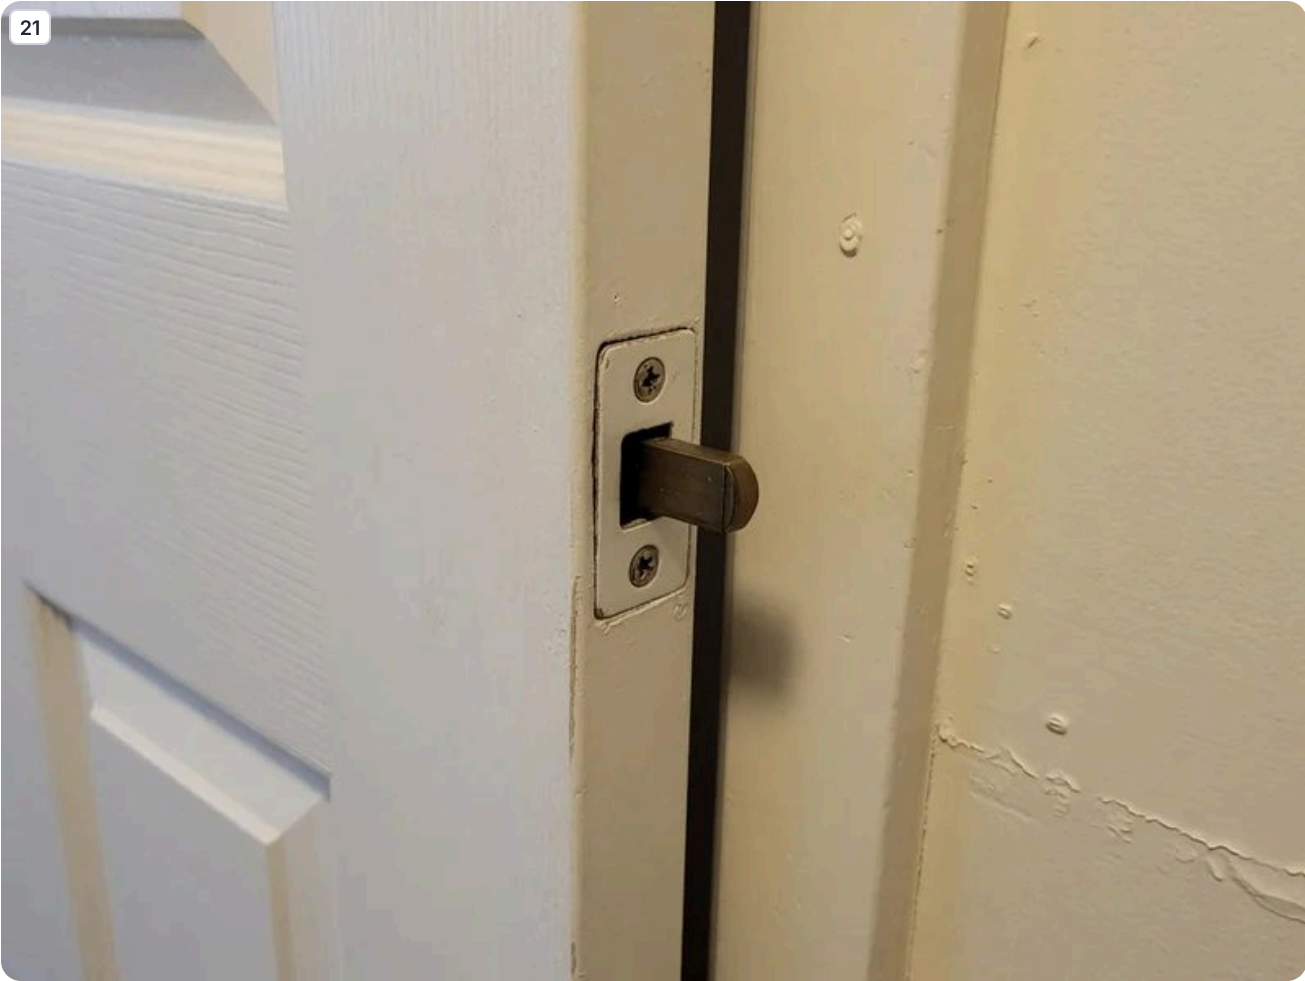
The front bedroom door does not latch because the latch bolt sits off the strike plate. Recommend the builder adjust the strike plate or the hinges so the door latches.

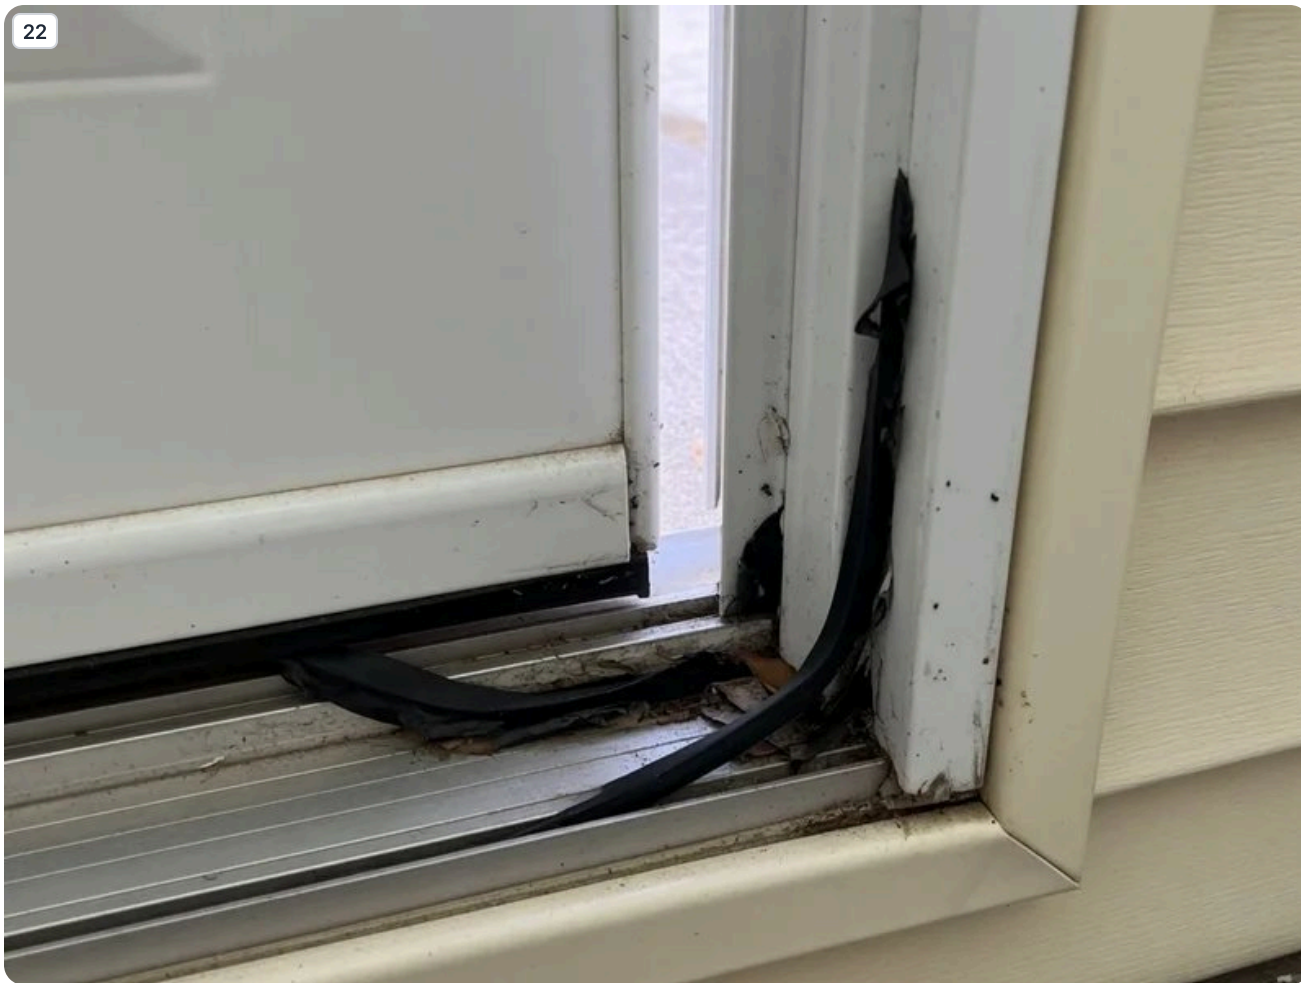
The weatherstrip at the bottom corner of the sliding patio door is loose and pulled out of its channel. Air and wind-driven rain can get past a loose seal. Recommend the builder reset or replace the weatherstrip.

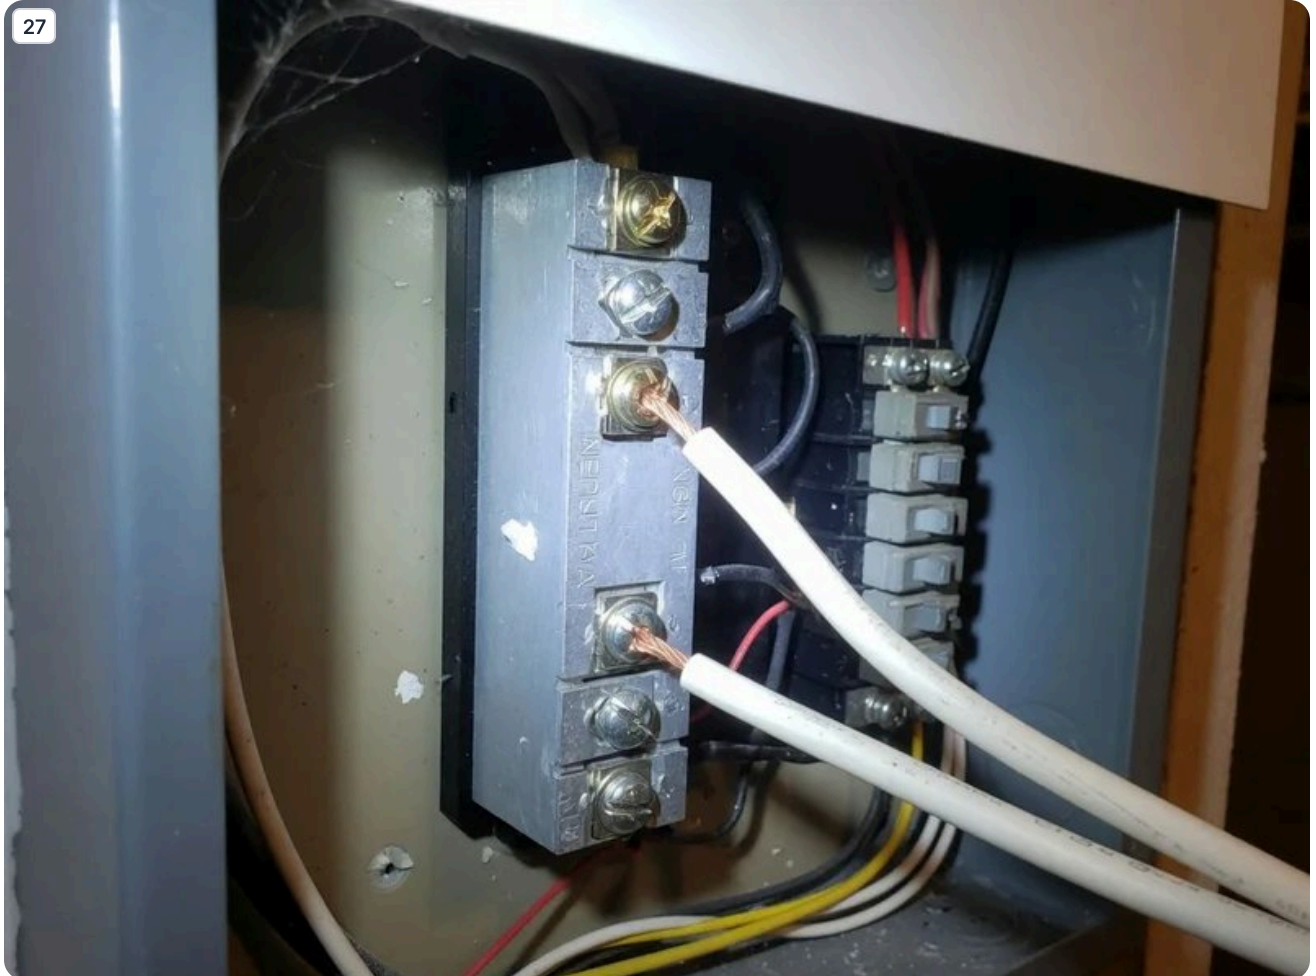
In the garage panel, two neutral wires share one terminal screw on the neutral bar. Each neutral should have its own terminal so one loose screw cannot affect two circuits. Recommend the builder's licensed electrician correct this.

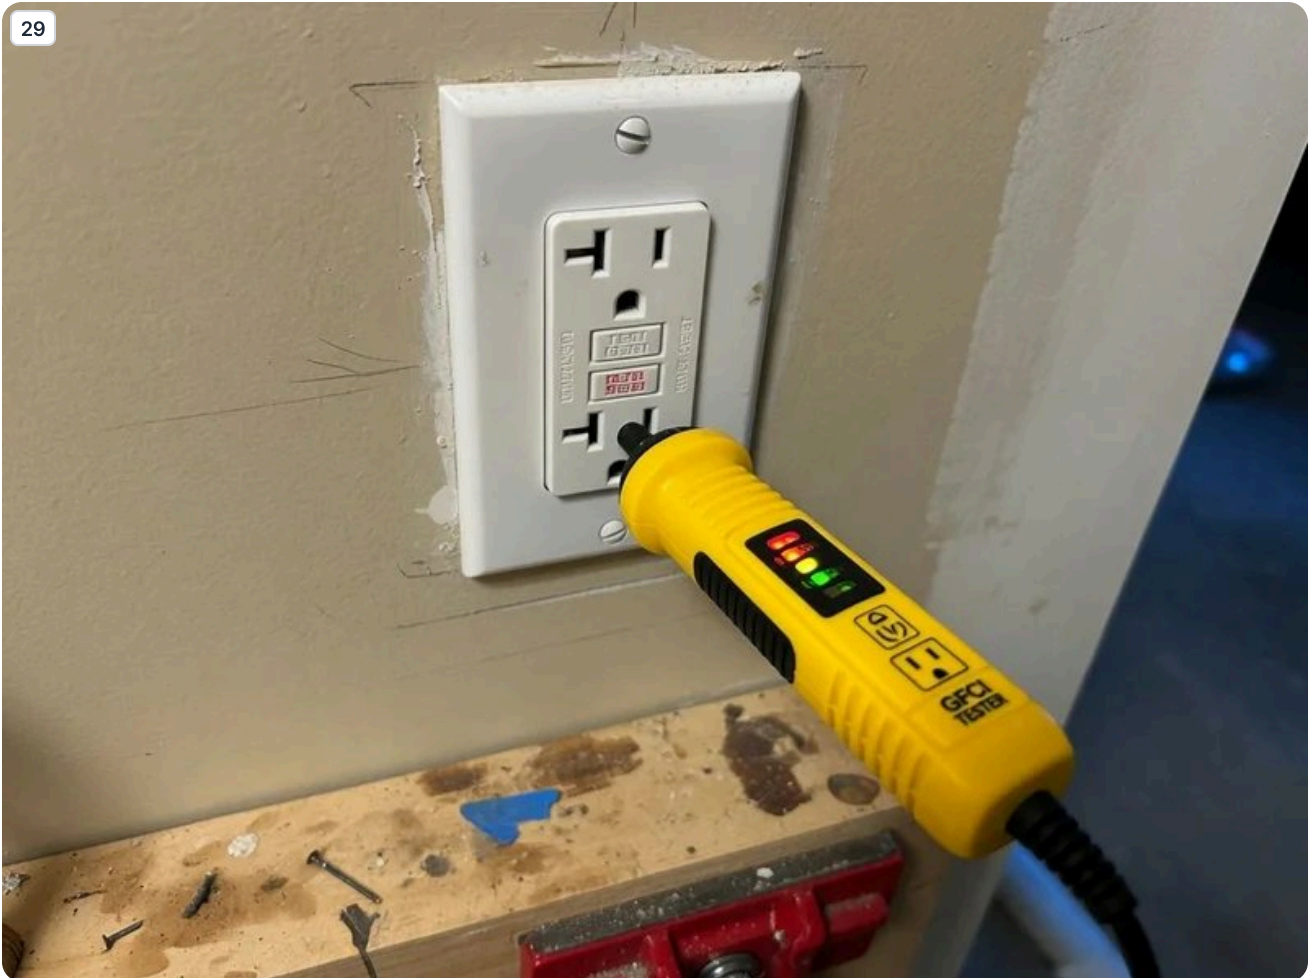
The garage receptacles did not have working GFCI protection. The GFCI receptacle at the garage workbench wall did not trip when tested, so it and the other garage receptacles on that circuit were not protected. Recommend the builder's electrician correct the GFCI protection at this location.

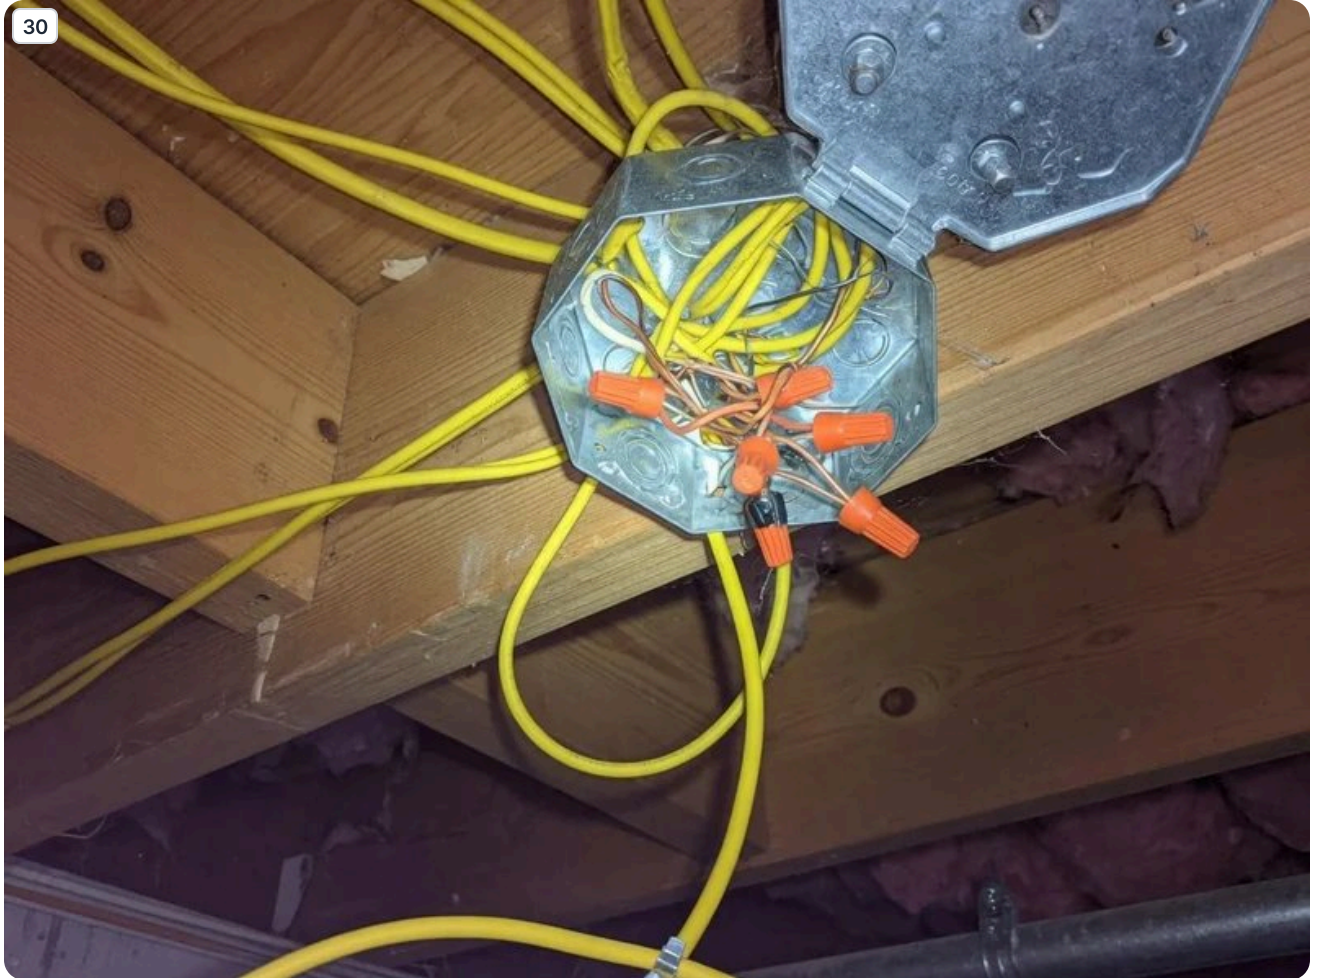
A junction box in the attic near the hallway hatch has no cover, leaving its wire splices exposed. Open splices can be touched or damaged and are a shock and fire risk. Recommend the builder's licensed electrician install a cover.

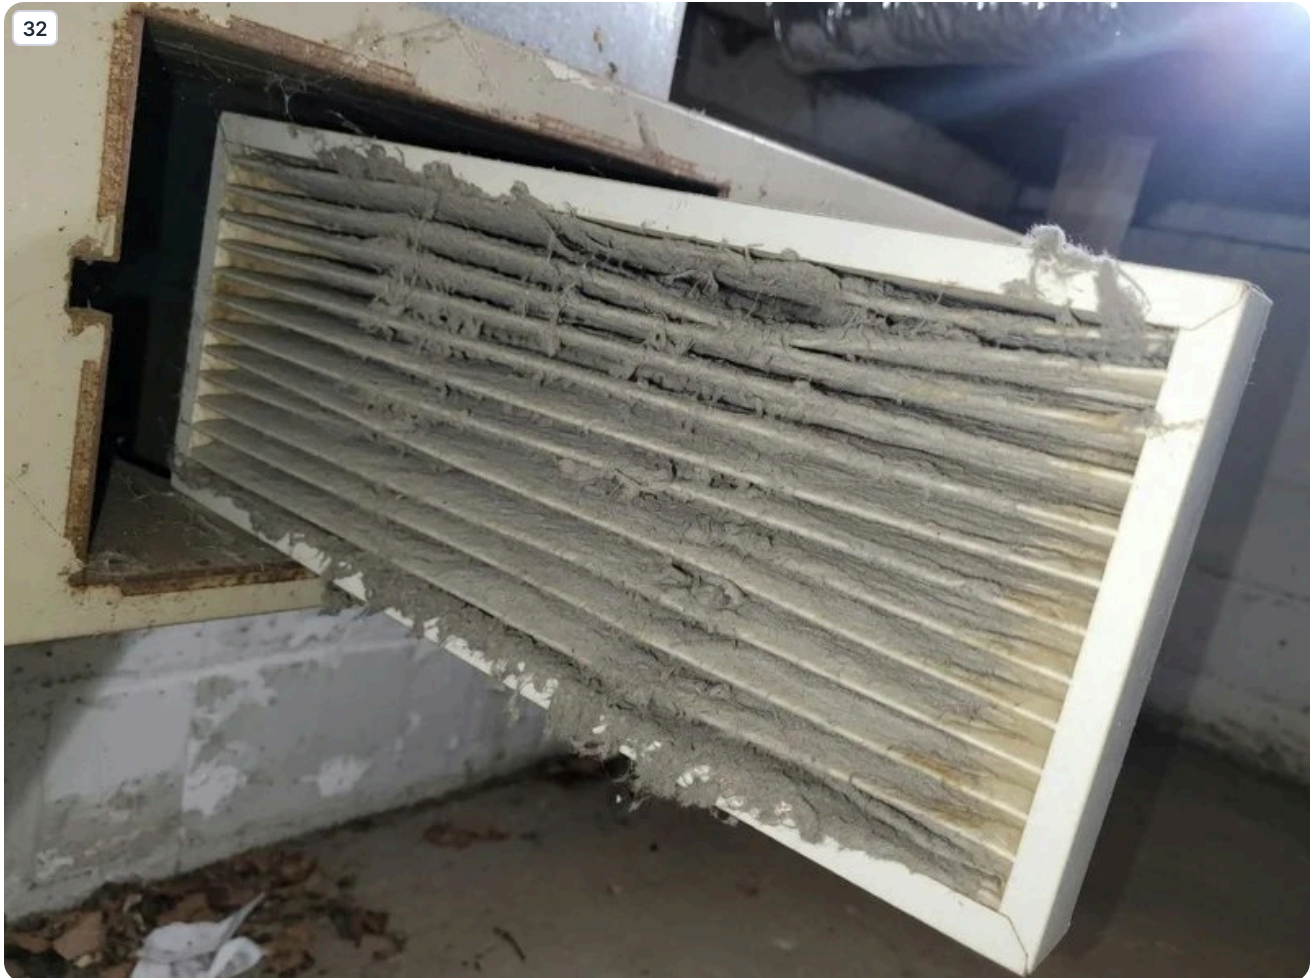
The return air filter in the hallway is already loaded with drywall and construction dust. A clogged filter cuts airflow and lets dust into the new ducts and coil. Recommend replacing the filter at closing and again soon after move-in.

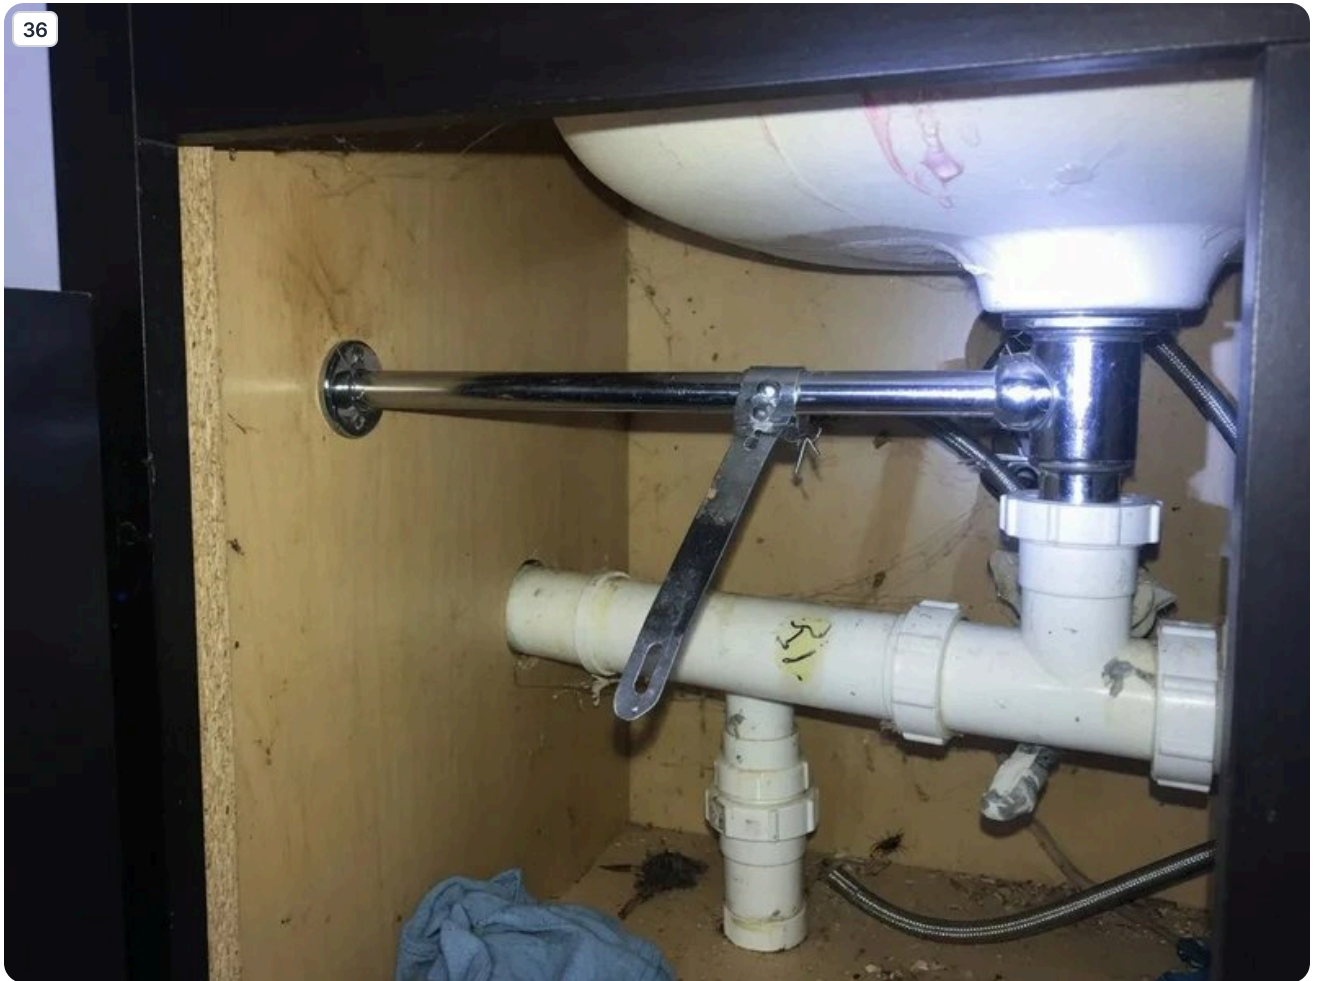
The pop-up stopper rod under the hall bath sink is not connected, so the stopper does not open or close. Recommend the builder connect the linkage.

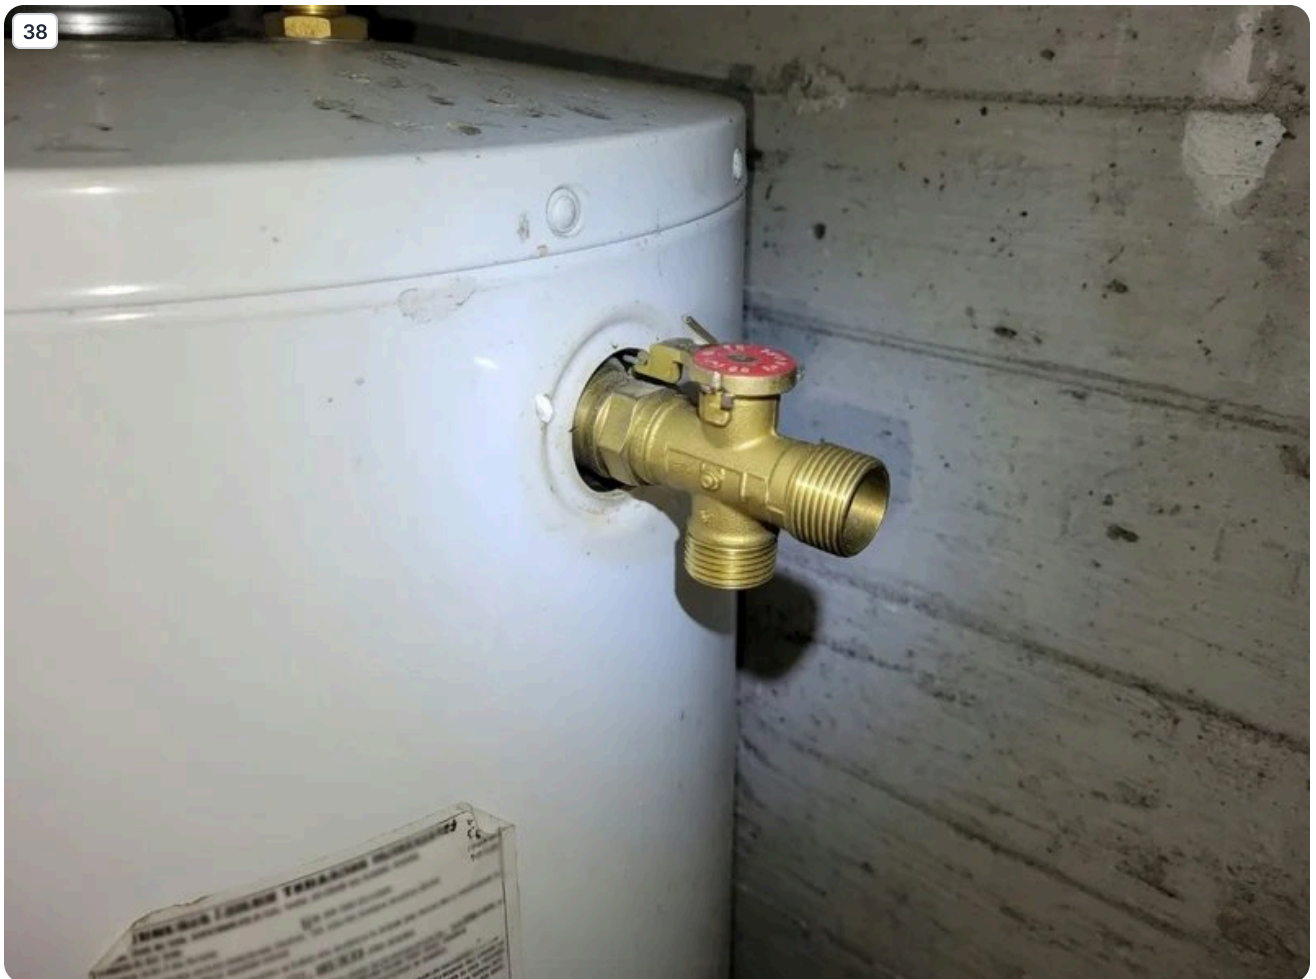
The temperature and pressure relief valve has no drain line attached. If the valve opens, scalding water would spray out at the heater where someone could be standing. Recommend the builder's licensed plumber install a drain line of approved material to an approved location.

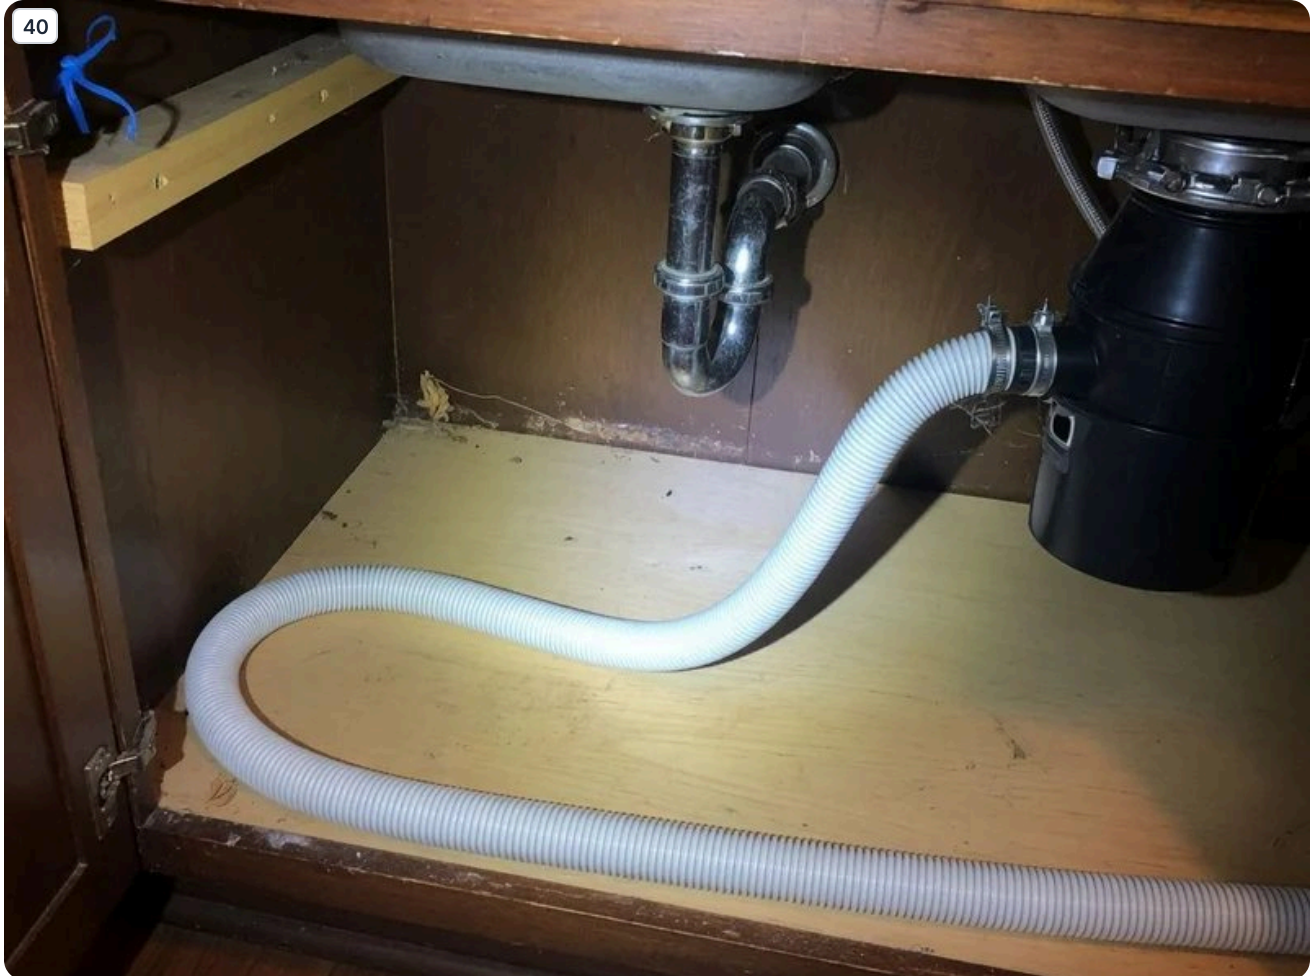
The dishwasher drain hose lies on the sink cabinet floor with no high loop and no air gap. Without one, dirty sink water can drain back into the dishwasher. Recommend the builder fasten the hose up high under the counter.

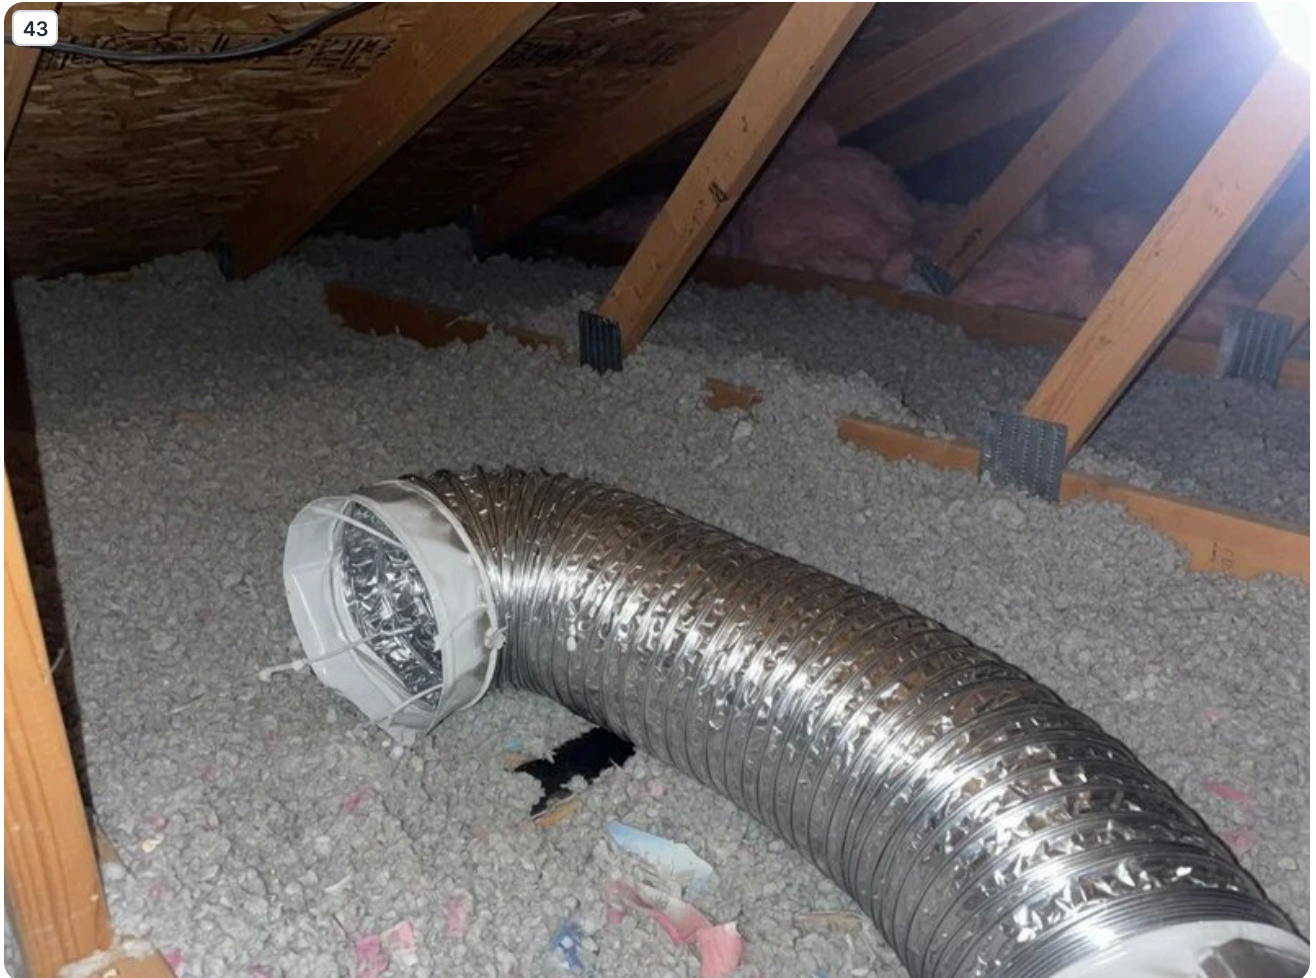
The hall bath exhaust fan duct is not connected to a roof or wall vent cap; it ends loose in the attic. Warm, moist air from showers will blow into the attic, where it can wet the insulation and roof decking. Recommend the builder extend the duct to an exterior vent cap.

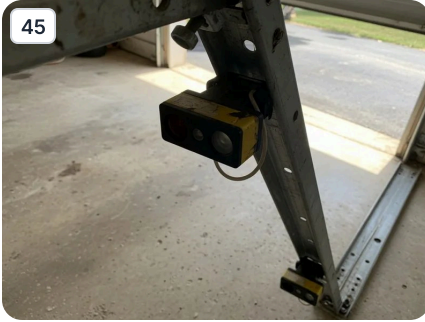
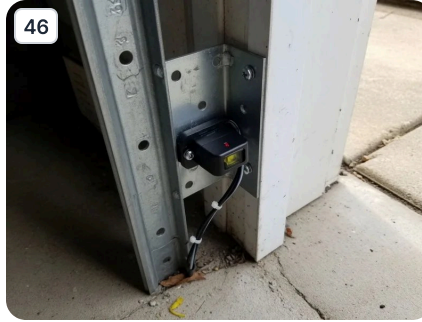
The safety sensors on both sides of the garage door are mounted about 12 inches above the floor. They should be no more than 6 inches high so they can see a small child or pet under the closing door. Recommend the builder lower the sensors and retest the door.
