PEDERNALES PEAK INSPECTIONS

TEXAS TREC REI 7-6 PROPERTY INSPECTION

# 7214 Manchaca Vista Dr Austin, TX 78745

## Austin Property Inspection Report

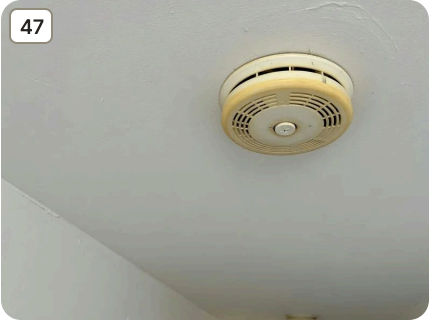
Several smoke detectors in the home appear original to construction and exceed the roughly ten-year service life smoke-alarm manufacturers specify; manufacture dates were no longer legible on the units checked. No carbon monoxide detector was found near the sleeping areas despite the presence of gas appliances. Recommend replacing every smoke detector older than ten years and installing a carbon monoxide detector near the sleeping areas.

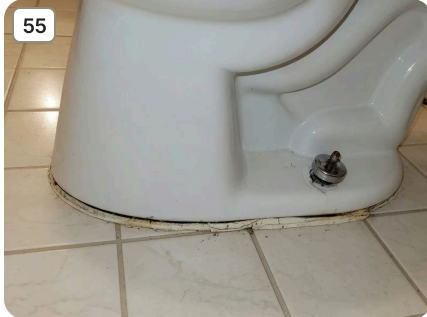
**Loose toilet in upstairs bath****MAJOR DEFICIENCY**

The upstairs hall bath toilet rocks at the base and the caulk around it is worn. A loose toilet can break its wax seal and leak into the floor, and it may be the source of the ceiling stain below (see I.F). Recommend a licensed plumber reset the toilet on a new seal.

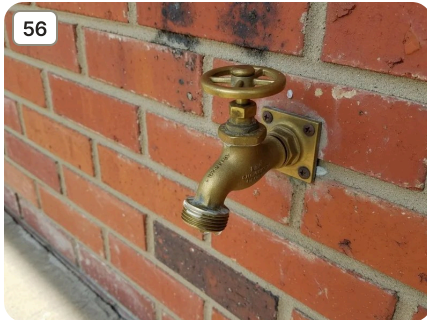
**No backflow devices at hose bibs****MAINTENANCE ITEM**

The front and rear hose bibs have no vacuum breakers. These stop dirty water in a hose from being pulled back into the home's water. Install screw-on vacuum breakers.

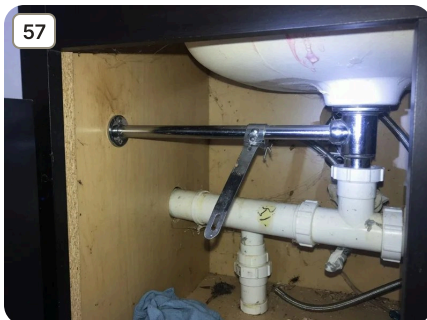
**Sink stopper disconnected****MAINTENANCE ITEM**

The pop-up stopper rod under the primary bath left sink is disconnected, so the stopper does not close. Reconnect or replace the linkage.

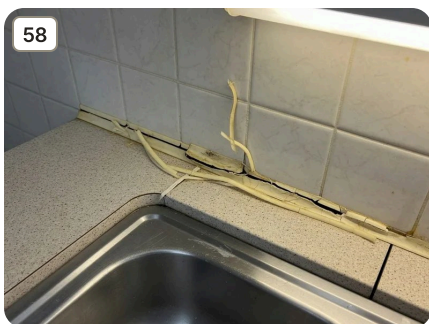
**Failed caulk at kitchen backsplash****MAINTENANCE ITEM**

Caulk has cracked and pulled away where the kitchen counter meets the backsplash behind the sink. Water can run into the wall and the sink cabinet. Clean out the old caulk and reseal.

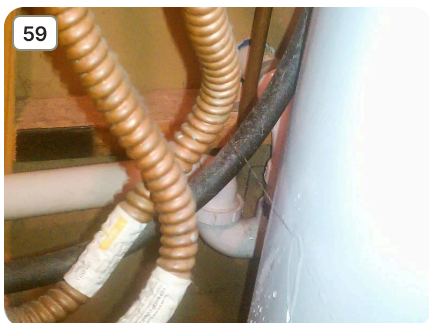
**Leaking water heater, no pan****SAFETY HAZARD**

An active water leak was observed at the base of the gas water heater's fittings at the time of inspection, and there is no drain pan beneath the unit to contain drainage; its temperature-and-pressure relief valve discharge line also terminates inside the closet rather than to the exterior. Recommend prompt evaluation and repair by a licensed plumber, including a properly routed drain pan and correcting the TPR discharge line to terminate outside within 6 inches of the ground.

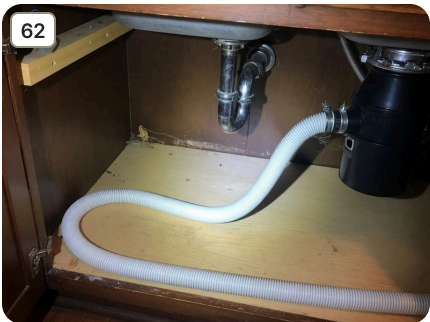
MINOR DEFICIENCY

The dishwasher drain hose runs flat under the sink with no high loop or air gap. Dirty sink water can flow back into the dishwasher. Raise the hose and fasten it to the underside of the counter.

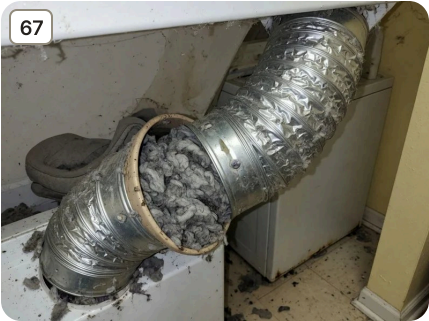
MAJOR DEFICIENCY

Lint has packed the dryer duct behind the dryer, and the flap on the rear wall cap is held open by lint. Lint in a dryer duct is a fire hazard and makes the dryer run hot. Clean the whole duct run and the wall cap, and clean it once a year.
