**Pedernales Peak Inspections**

TEXAS TREC REI 7-6 PROPERTY INSPECTION

**1140 Ranch Road 12 Dripping Springs, TX 78620**

**Texas Property Inspection Report**

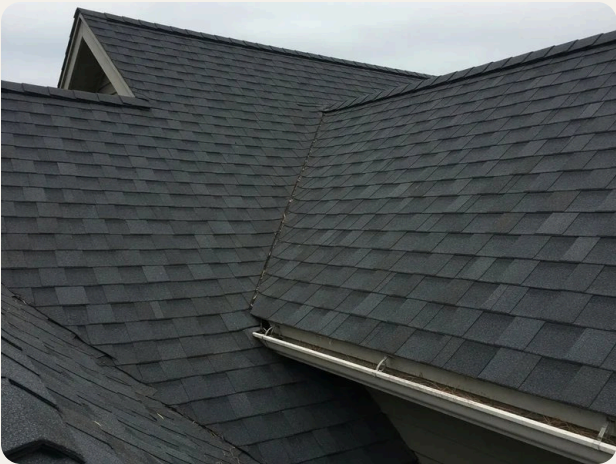
5

The composition slopes on the rear addition and garage wing were walked. Shingles showed general granule loss, curled edges and cracked tabs, as listed below. Valleys are closed-cut and the eaves have metal drip edge.

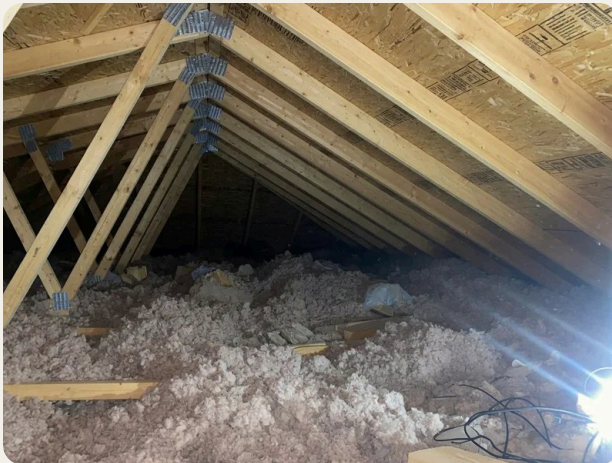
12

The attic was entered from the pull-down ladder in the garage; a second scuttle hatch is in the hall closet. The roof is framed with 2x8 rafters and 2x6 ceiling joists over plywood decking. No broken or sagging framing was seen.

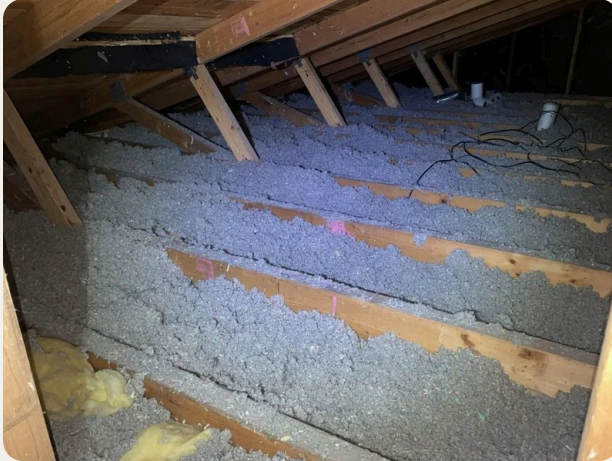
13

Blown fiberglass covers the ceilings, with batts at the rear addition knee walls. Coverage was fairly even over the main house and thinner at the garage wing and at the eaves.

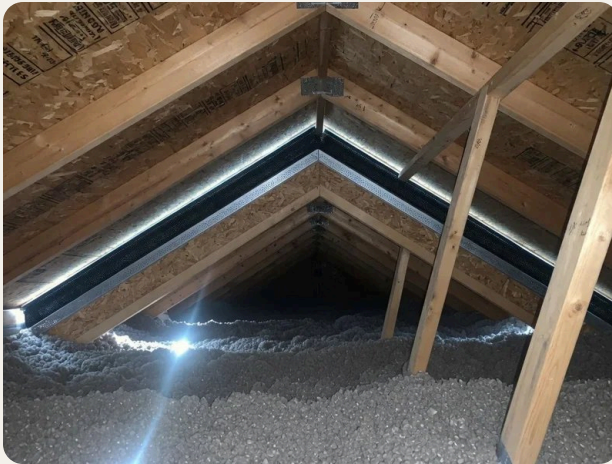
14

The attic is vented by soffit vents at the eaves and ridge and box vents at the top. Airflow appeared adequate where the soffit vents were clear.

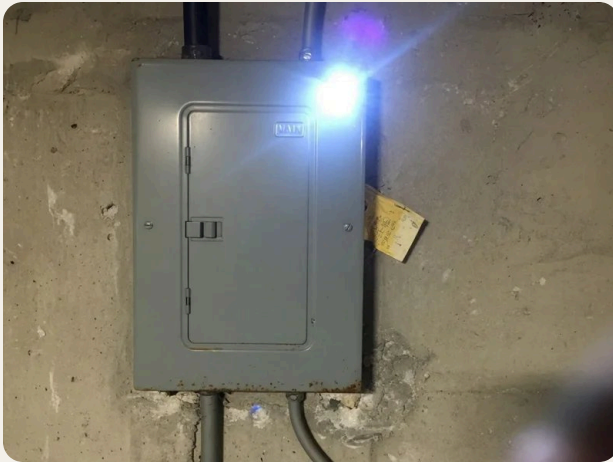
36

The main panel is on the garage wall: 200 amp main breaker, 40 spaces. The dead front was removed. No signs of overheating or burned insulation were seen.

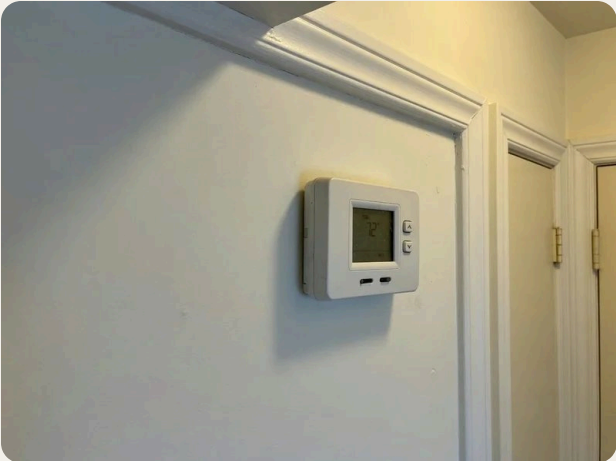
45

**Heating system**  
Gas forced-air furnace in the attic, about 80,000 BTU, made in 2014 per the data plate. It is controlled by a thermostat in the hall.

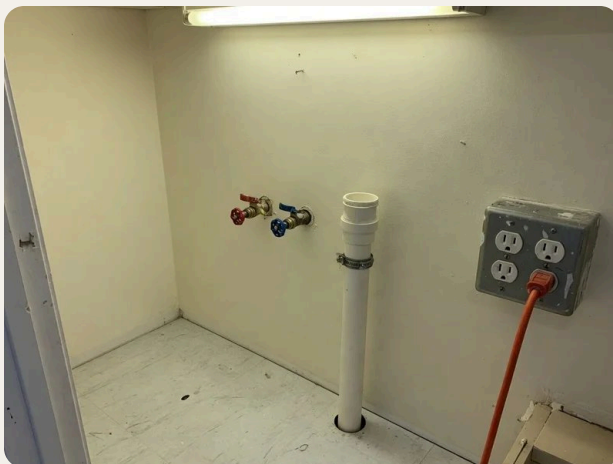
66

The laundry has a gas dryer stub and a 240 volt dryer outlet. The dryer duct runs about 12 feet through the wall to a hood on the garage wing.
