Pedernales Peak Inspections

Round Rock New Construction Inspection Report

September 28, 2026

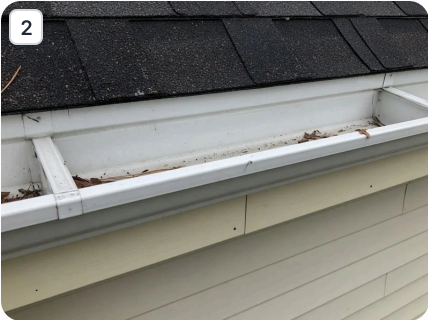
Gutters and downspouts

Gutters with downspouts are installed along the rear roof edge. The front and side roof edges have no gutters, which is common on new homes in this area; water from those edges falls onto the landscape beds.

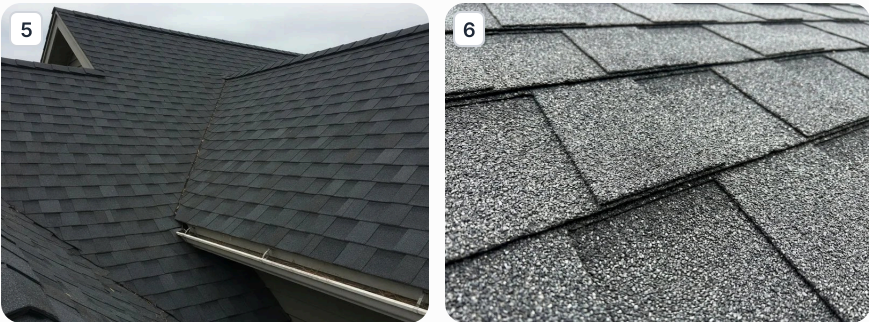
Roof covering

The roof is covered with new architectural (laminated) composition shingles installed with the house. The roof was walked. The shingles lay flat and were sealed down, with straight courses and even exposure.

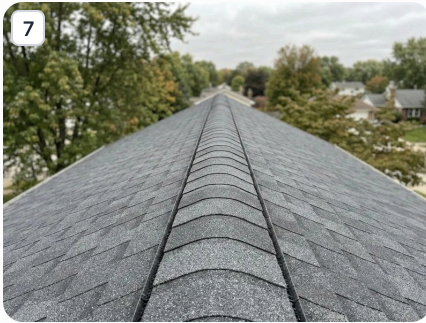
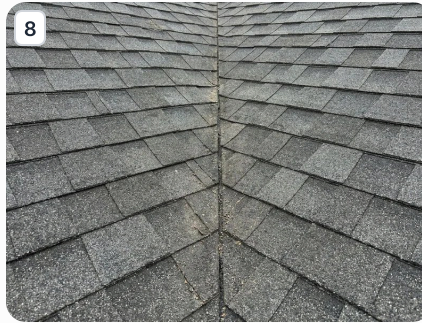
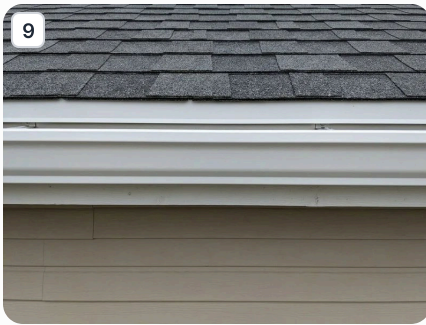
**Valleys, ridge and flashing**

The valleys are closed-cut shingle valleys. The ridge has a continuous ridge vent under cap shingles. The plumbing vent boots, the drip edge and the step flashing at the walls were in place and looked properly installed where visible, except as noted below.

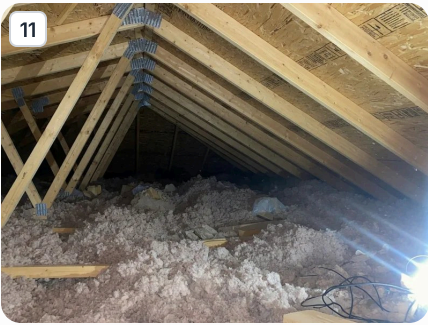
**Attic framing and access**

The roof is framed with engineered wood trusses and OSB roof decking. The attic was entered from the pull-down ladder in the garage and walked on the decked path to the air handler; a second access hatch is in the hallway ceiling. No damaged or cut truss members and no water stains were seen.

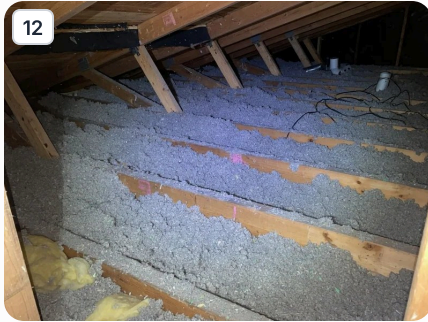
**Attic insulation**

The attic floor has blown-in loose-fill insulation about 12 to 15 inches deep, roughly R-38, spread evenly over the ceilings except as noted below.

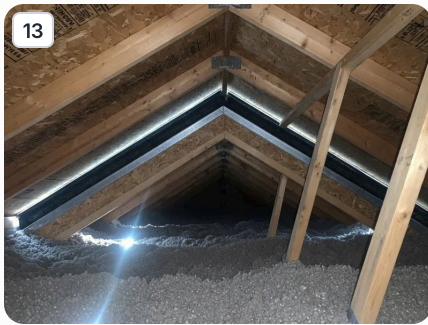
**Attic ventilation**

The attic is vented by soffit vents at the eaves and a continuous ridge vent at the peak, which lets air move from low to high through the attic.

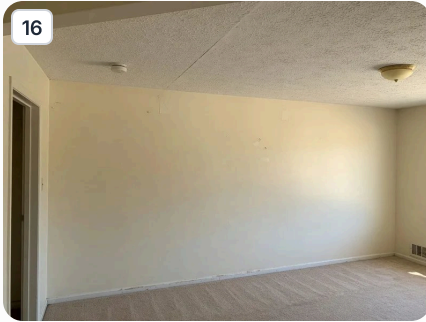
**Interior walls**

The interior walls are painted drywall with a light texture. With no furniture in the house, the walls could be seen in full. Apart from the items below, they were straight and fully finished.

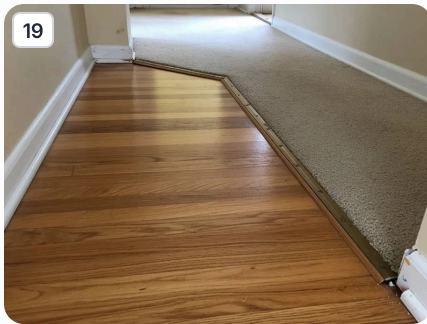
### Floors and ceilings

The floors are wood-look flooring in the main living areas, carpet in the bedrooms, and ceramic tile in the bathrooms and laundry room. The ceilings are painted drywall with a light texture. No stains, sags or cracks were seen in the ceilings.

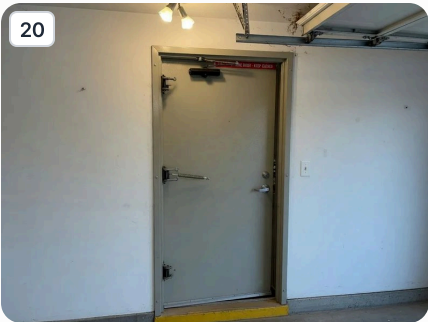
Garage entry door

The door between the garage and the house is a solid steel door with a self-closing device. It closed and latched on its own when tested, as it should to slow fire and fumes from the garage.

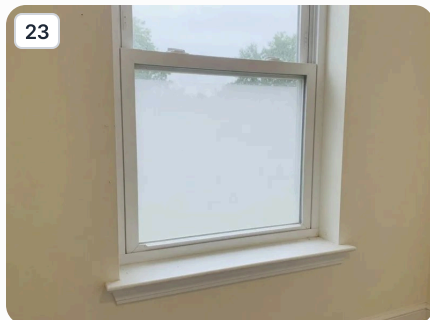
The windows are vinyl-framed, double-pane, low-E single-hung units. With the house empty, every window could be reached. They opened, closed and locked as intended, and no fogged glass was seen.

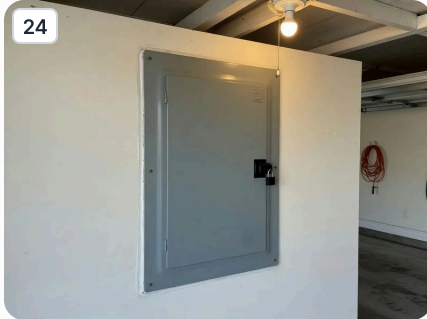
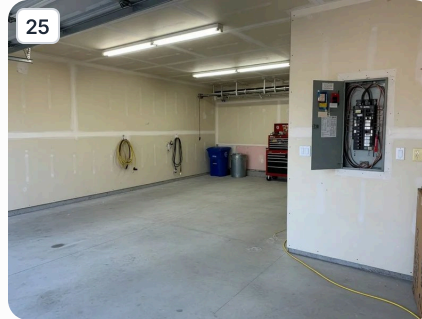
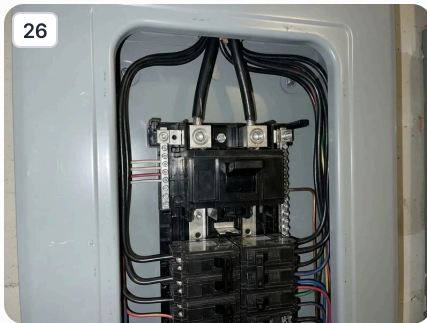
#### Service and panel

An underground service feeds a meter and main disconnect on the right side wall. The 200 amp distribution panel is on the garage wall. The panel was opened and the main breaker, branch wiring and neutral and ground bars were checked with the cover removed.

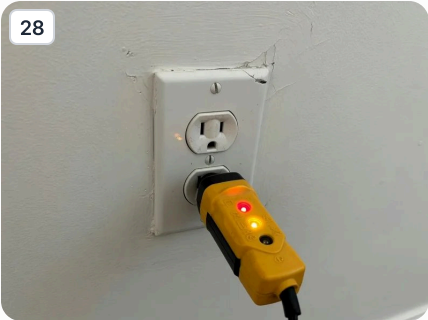
Receptacles, switches and fixtures

The branch wiring is copper non-metallic cable. Every accessible receptacle was tested and showed correct wiring, and the receptacles are the tamper-resistant type. Light fixtures, switches and ceiling fans worked.

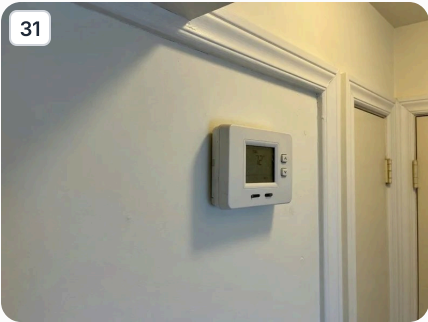
**Heating system**  
Heat comes from an electric heat pump split system, with the air handler in the attic and electric strip heat as backup. The equipment was made in 2026. The system was run in heat mode and delivered warm air at every register.

**Thermostat**  
A programmable thermostat is in the hallway. It controlled both the heating and the cooling.

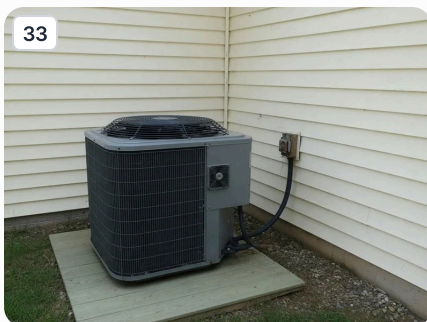
Cooling comes from a 3 ton heat pump condenser on a pad in the left side yard, made in 2026, using R-454B refrigerant. The breaker size matched the condenser's data plate.

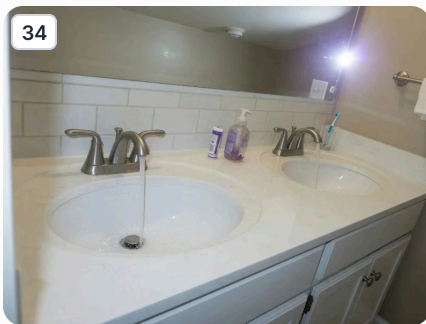
#### Water supply and fixtures

The water supply is PEX piping with the main shutoff valve in the garage. Static pressure measured 65 psi, within the normal range. Every sink, tub, shower and toilet was run and flushed, with no leaks seen at the fixtures.

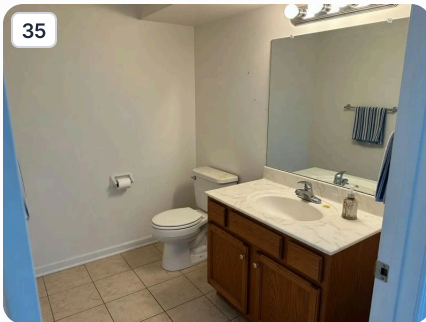
#### Bathrooms

The hall bath has a tub and shower combination, and the primary bath has a separate walk-in shower. The toilets were secure at the floor and refilled normally.

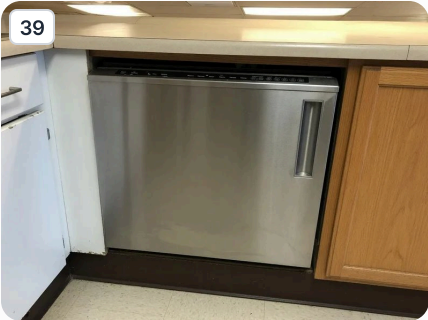
**Dishwasher**  
The dishwasher ran through a full normal cycle. It filled, washed and drained, with no leaks seen.

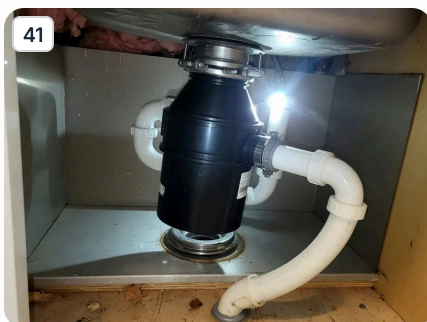
**Food waste disposer**

The food waste disposer ran with no unusual noise or leaks, and its wiring was secured at the unit.

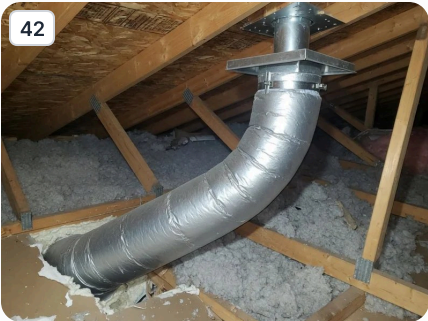
**Exhaust fans**

Exhaust fans are installed in both bathrooms and the laundry room, and each ran when switched on. The primary bath fan duct runs to a roof vent cap.

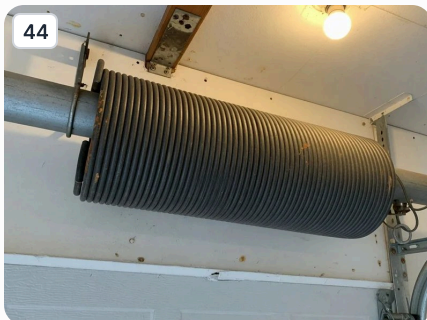
The garage has one overhead door with an automatic opener. The door opened and closed smoothly and reversed when it met resistance. The torsion spring and its hardware were in place.

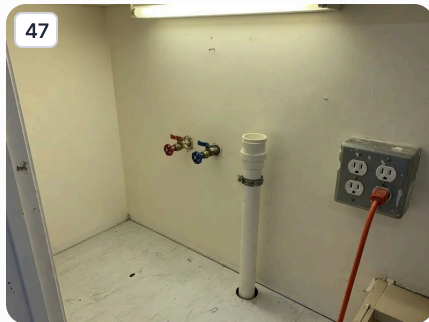
**Dryer exhaust**

The laundry room has a washer box, a standpipe drain and a dryer vent connection in the wall. The dryer duct runs through the attic to a roof vent cap, and the cap's flap opened and closed freely.
